CAPITOL COMPLEX MASTER PLAN  
FINDINGS & RECOMMENDATIONS (F & R) NEEDS ASSESSMENT  
CAPITOL ANNEX BUILDING, 1375 SHERMAN STREET (DENVER)

NOVEMBER 2014

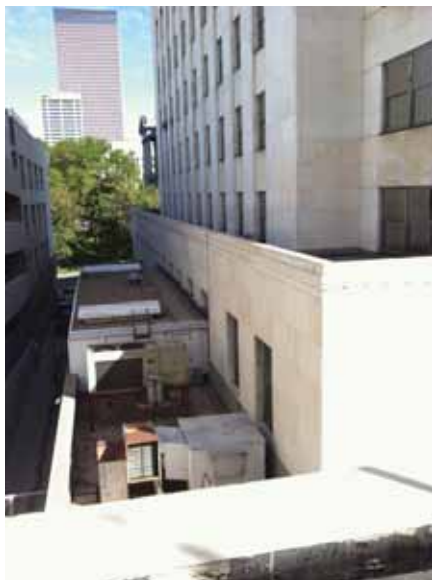
View of the Back/West alley between the Capitol Annex Building and the parking garage to the west, looking north

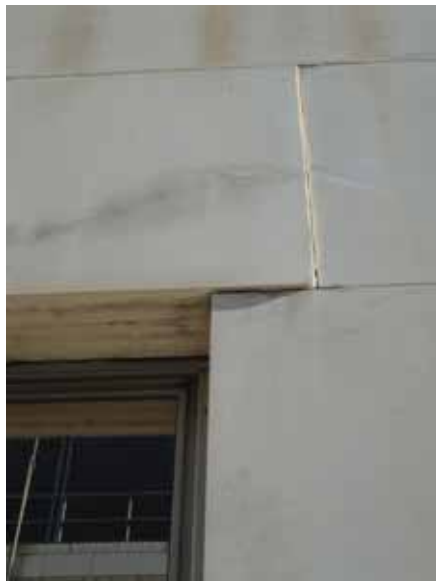
Fig. 2.1.A.1 Marble panel cracking/  
moving out of flush.

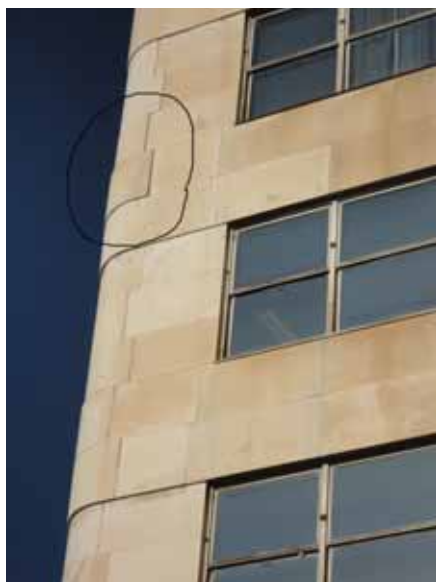
Fig. 2.1.A.2 Marble panels moving out  
of flush.

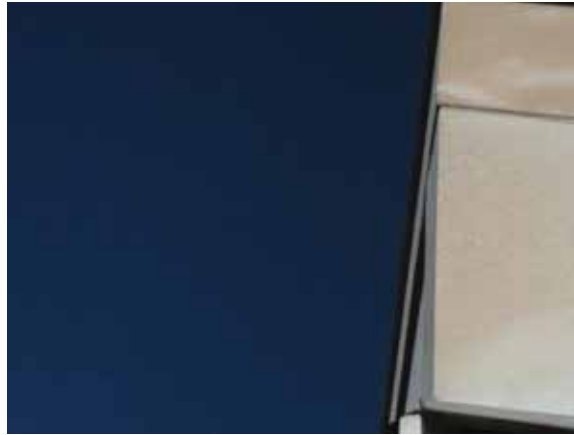
Fig. 2.1.A.3 Panels cladding the Penthouse are in generally poor condition.

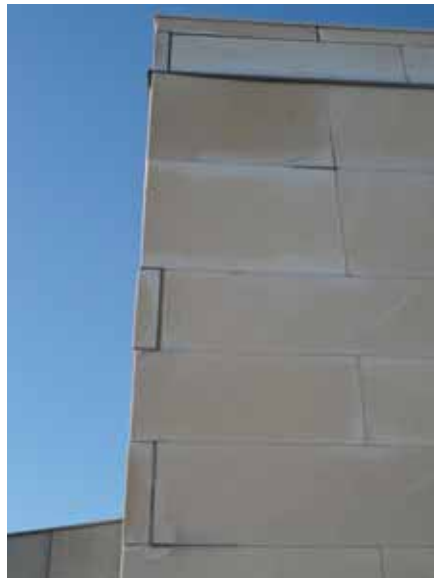
Fig. 2.1.A.4 Staining of marble panels cladding the Penthouse from previous repairs using an incorrect type of sealant.

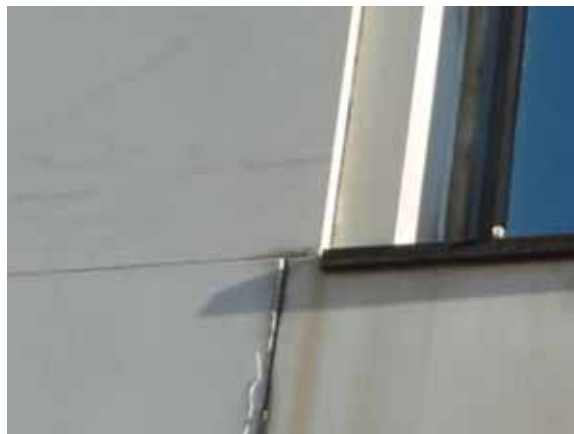
Fig. 2.1.A.5 Marble panels with staining due to window frame corrosion, with joint deterioration, and moving out of flush.

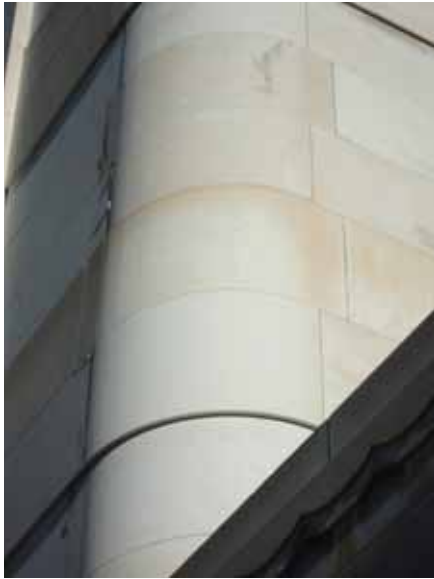
Fig. 2.1.A.6 Soiled rounded marble corner panels with joint deterioration.

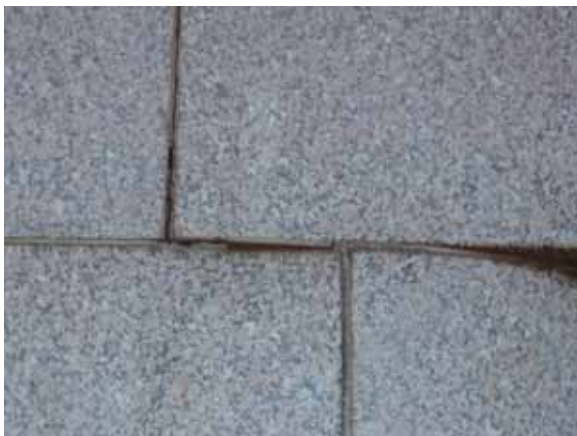
Fig. 2.1.A.7 Deteriorated sealant between granite panels.

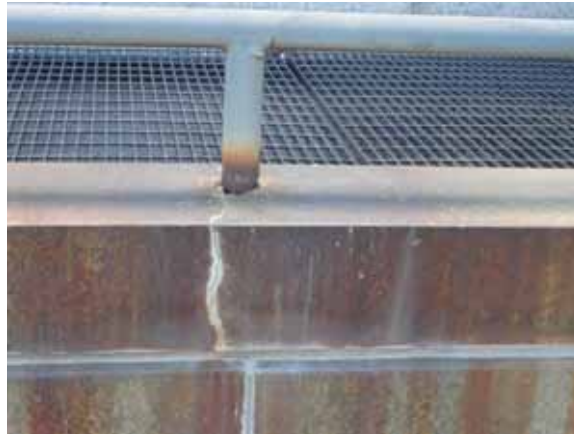
Fig. 2.1.A.8 Damage and staining to low granite wall enclosing the window well from corroded low pipe railing.

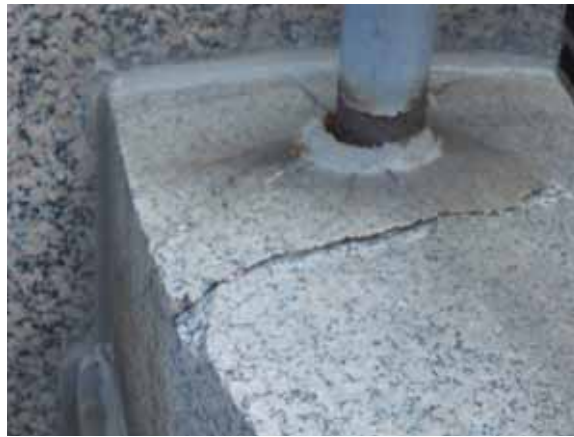
Fig. 2.1.A.9 Damage to low granite wall enclosing the window well.

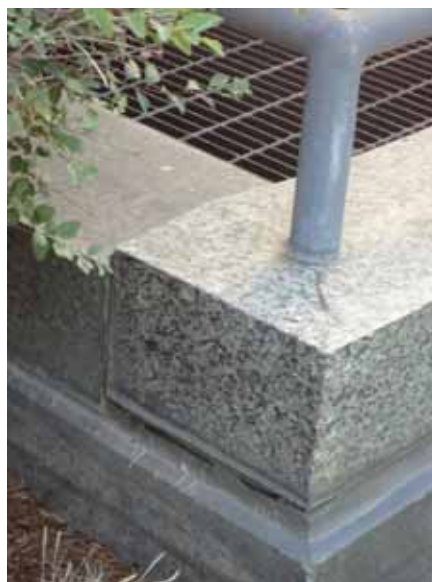
Fig. 2.1.A.10 Granite block coming loose at the corner of the low window well wall.

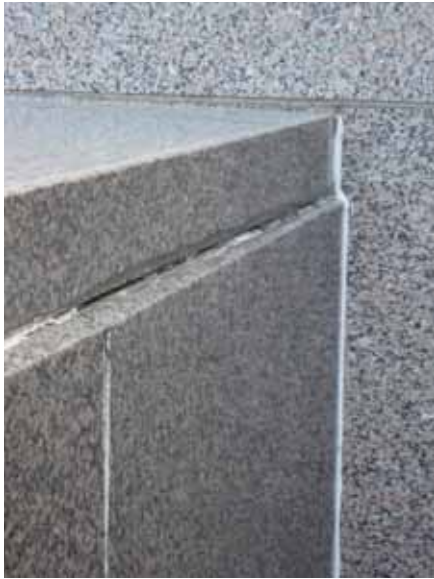
Fig. 2.1.A.11 Deteriorating sealant between granite panels.

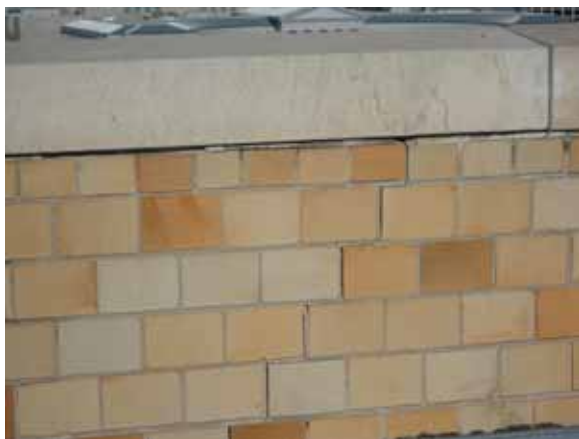
Fig. 2.1.A.12 Inside face of the roof parapet with a stepped crack.

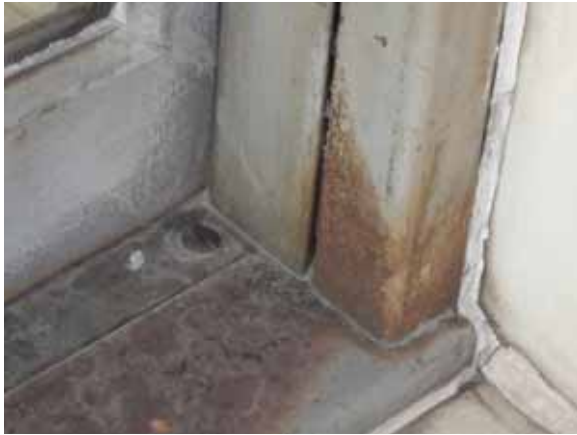
Fig. 2.1.A.13 Corroding metal window frame.

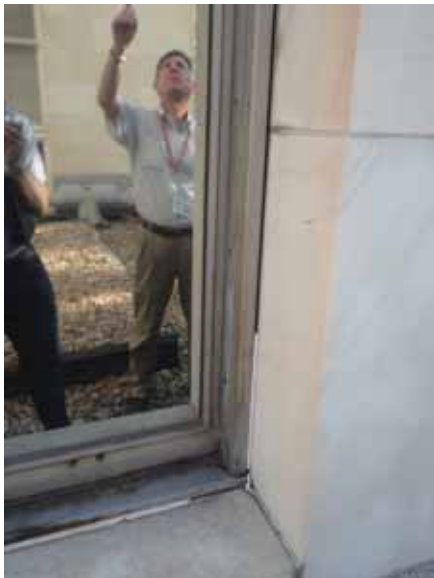
Fig. 2.1.A.14 Corroding metal window frame and deteriorating sealant.

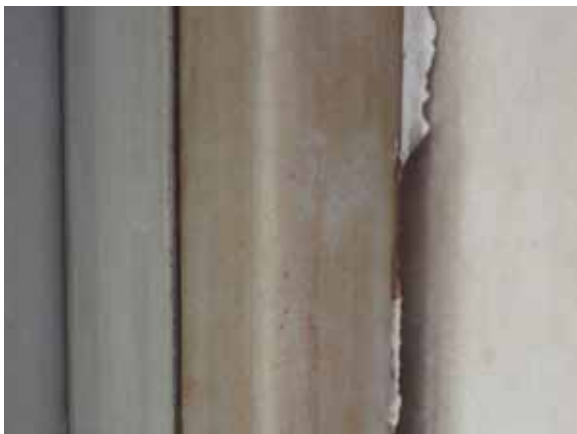
Fig. 2.1.A.15 Deteriorating sealant surrounding window frames.

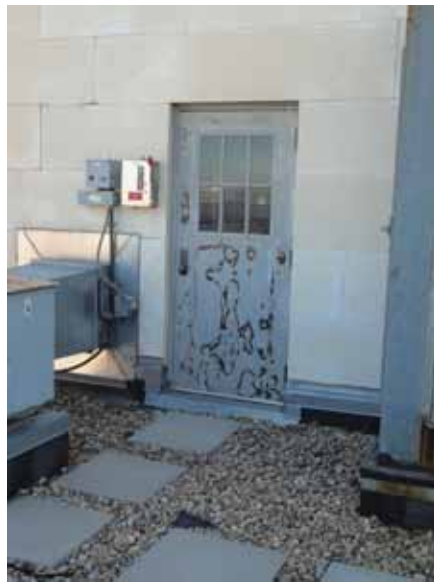
Fig. 2.1.A.16 Corroding door at the Penthouse Level.

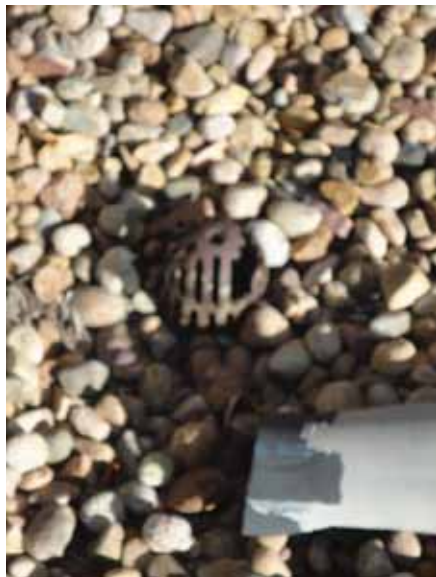
Fig. 2.1.A.17 Corroded drain cover, south roof at grade level.

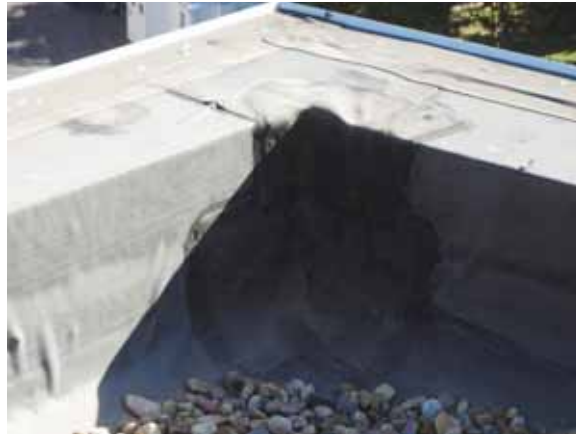
Fig. 2.1.A.18 Repairs to roof membrane and bubbling of roof membrane.

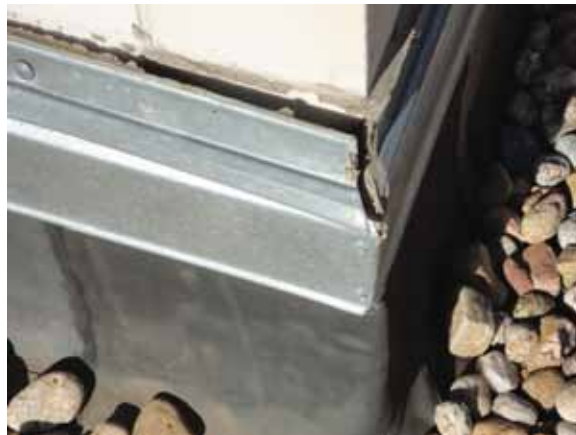
Fig. 2.1.A.19 Flashing pulling away from the Penthouse wall.

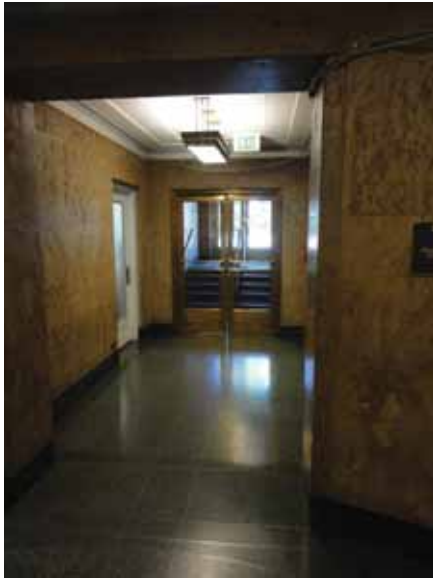
Fig. 2.1.B.2 The north 14th Avenue Entrance at the Basement Level has four steps up to grade and is therefore not an accessible entrance.

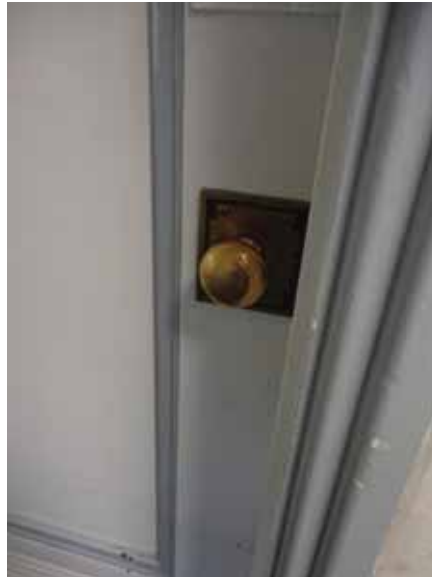
Fig. 2.1.B.3 Knob-style door handles do not meet accessibility code requirements.

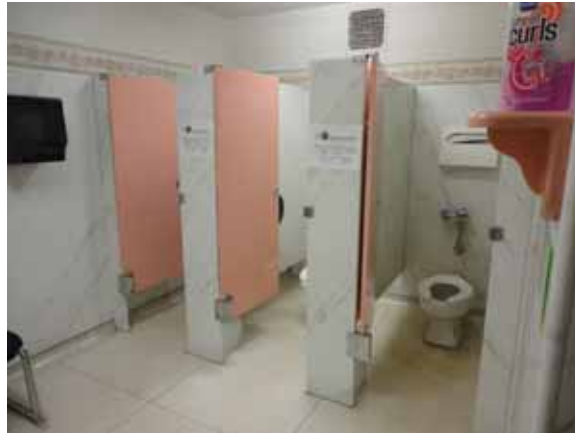
Fig. 2.1.C.2 Typical non-accessible bathroom stalls.

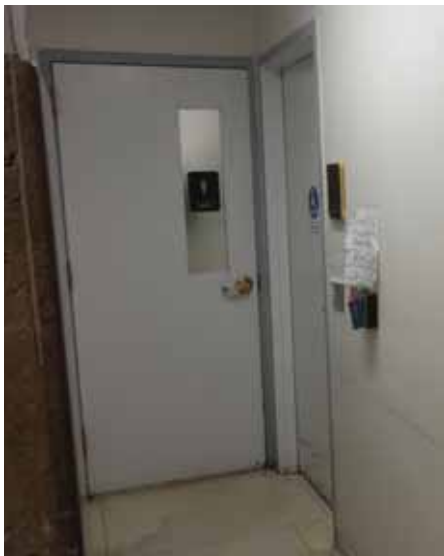
Fig. 2.1.C.6 Unisex Restroom at the Basement Level with broken automatic door opener and with accessible entry space infringed upon by the nearby Men's Restroom door which swings out into the space.

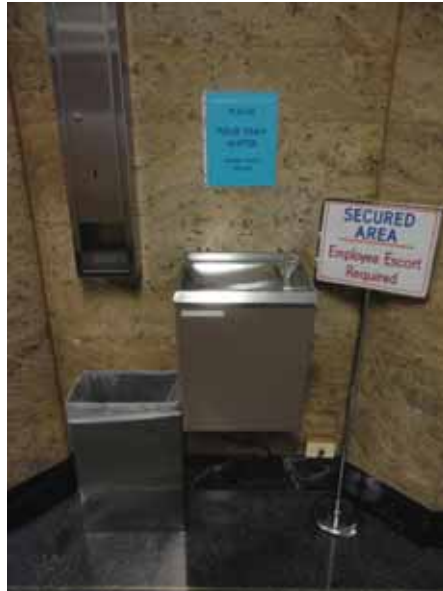
Fig. 2.1.C.7 Typical non-accessible drinking fountain.

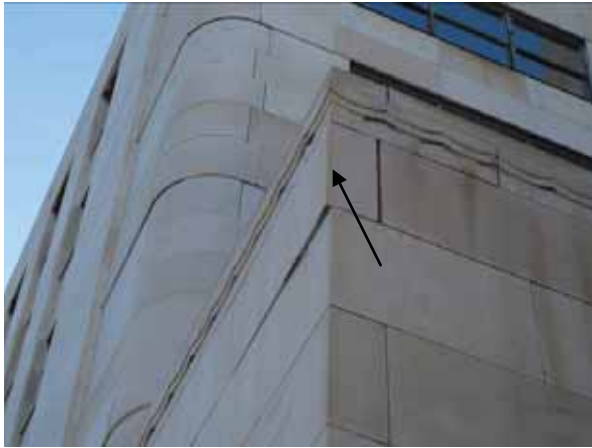
The building's exterior is showing signs of distress. Several veneer tiles are inadequately secured to the building's framing and the mortar joints at many of the tiles have deteriorated (Fig. 2.2.A.1). Additional damage may be present behind the panels due to water intrusion and is not readily observable. The condition of the panels also represents a life safety hazard to pedestrians and should be corrected in the near future.

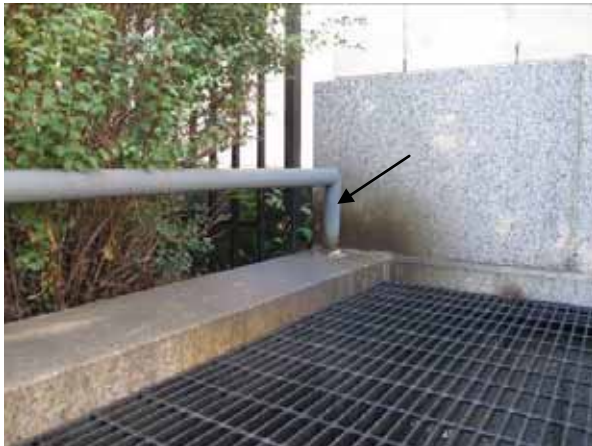
Railing along the east retaining wall near the main entrance was severely corroded (Fig. 2.2.A.2). The vertical posts have become disconnected from the wall due to their corroded condition. The corrosion has caused additional cracking in the capstones along the retaining wall. One of the capstones at the southeast corner of the retaining wall has pulled up approximately 1 inch and a panel at the northeast corner of the wall has become loose (Fig. 2.2.A.3).

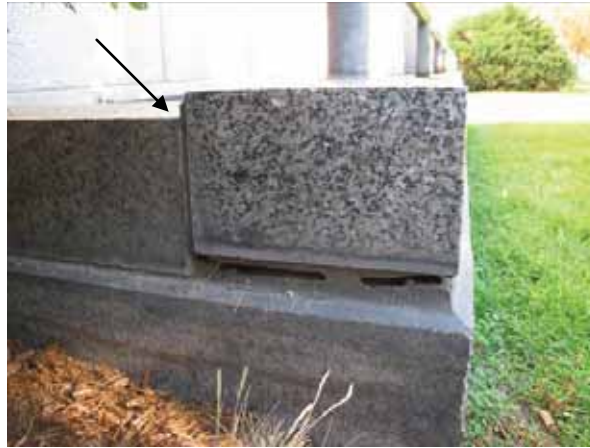
## 2.0 OVERALL BUILDING ASSESSMENT FINDINGS & RECOMMENDATIONS

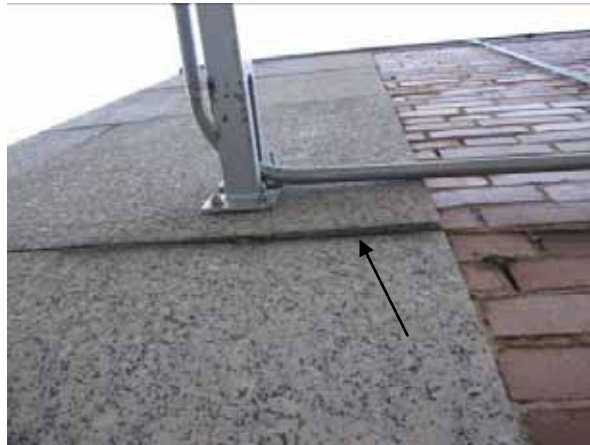
A metal tube supporting conduit on the west side of the building connects the parking garage to an exterior panel (Fig. 2.2.A.4). The panel is loose and should be repaired.

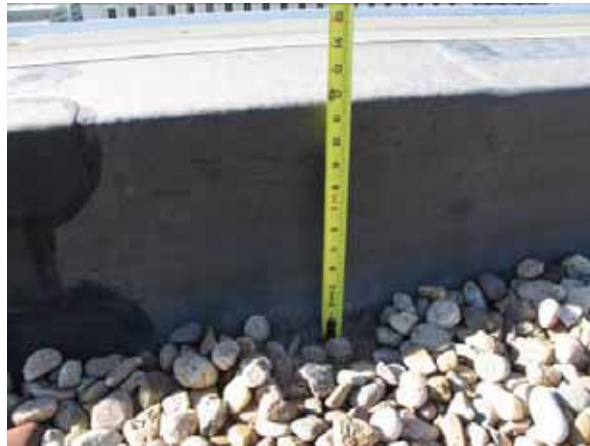
Inadequate parapet heights were observed adjacent to the loading dock and the upper roof levels (Fig. 2.2.C.1). Parapets should be at least 42 inches tall or fall protection provided for access near the exposed edges to meet current safety codes.

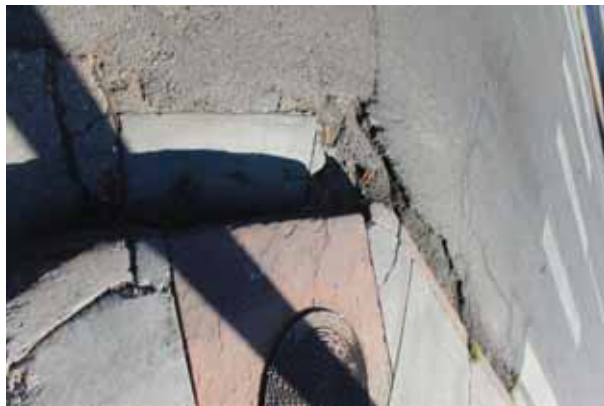
Figure 2.3.A.2 – Street Inlet

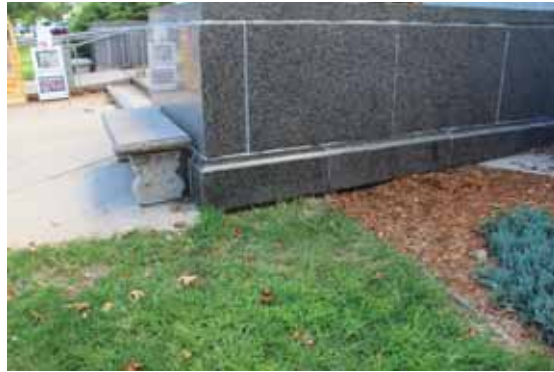
Figure 2.3.A.5 – Marble Site Wall Settling

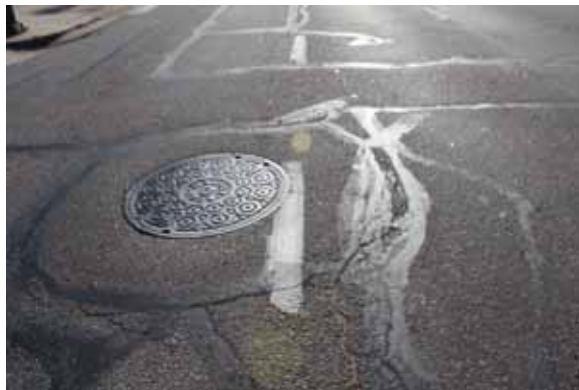
Figure 2.3.A.6 – Street Utilities

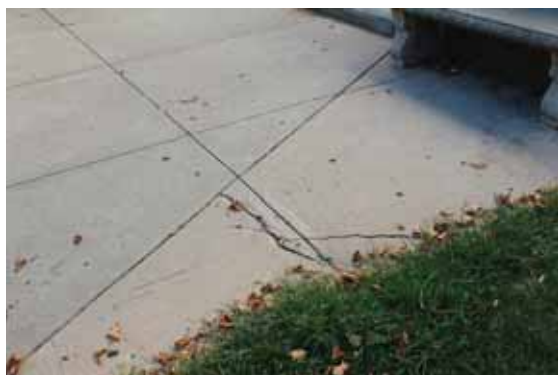
Figure 2.3.A.7 – Site Concrete Crack

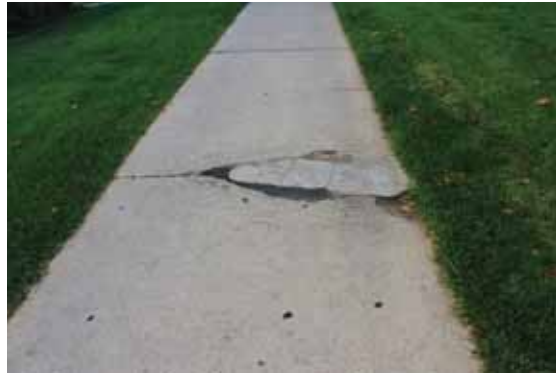
Figure 2.3.A.8 – Site Concrete Patch, Recommended for Replacement

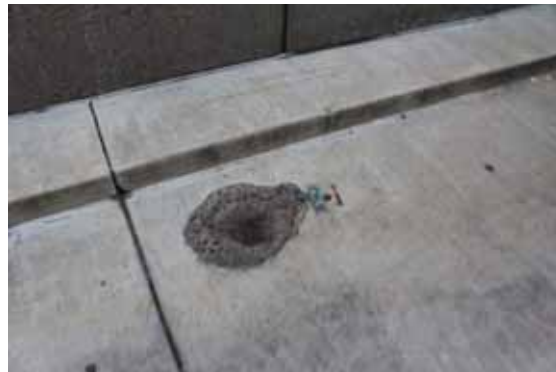
Figure 2.3.A.9 – Broken Site Concrete, Recommended for Replacement

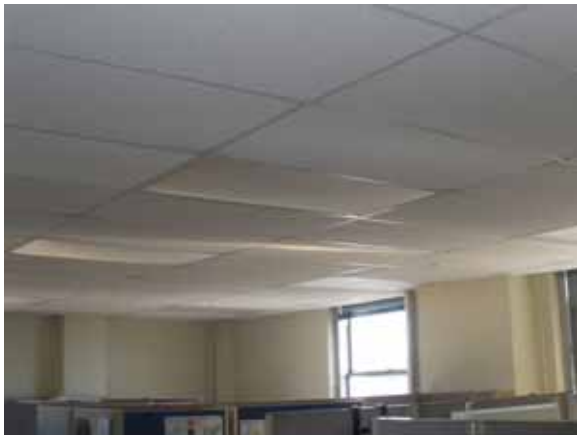
Fig. 2.4.A.2 - New Light Fixtures

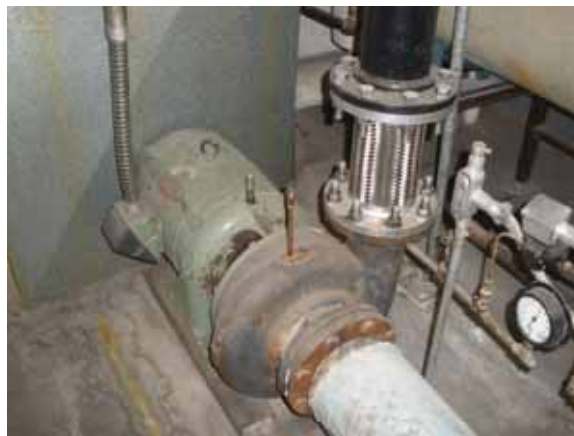
Fig. 2.4.A.3 - Building Chilled Water Pump

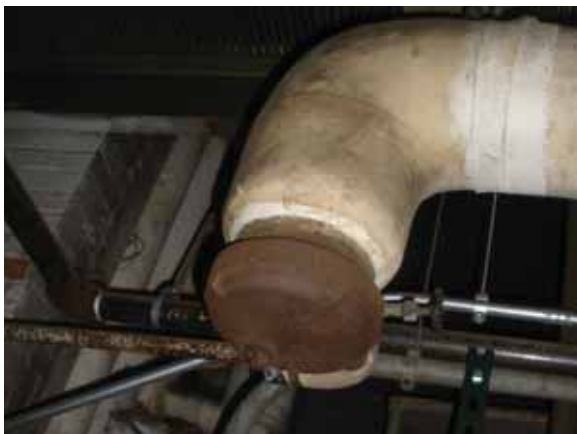
Fig. 2.4.A.6 - Abandoned Steam Pipe

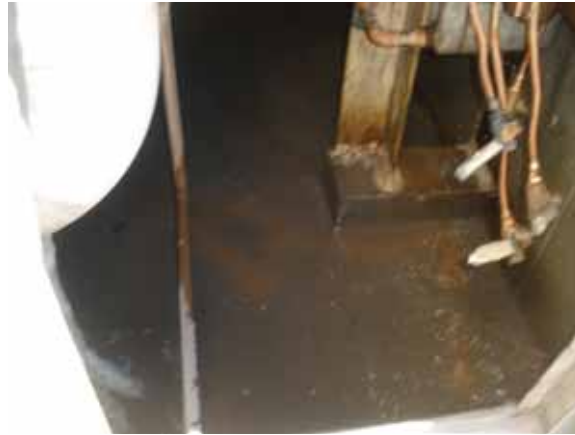
Fig. 2.4.A.7 – Standing water in AHU Cooling Coil Drain Pan

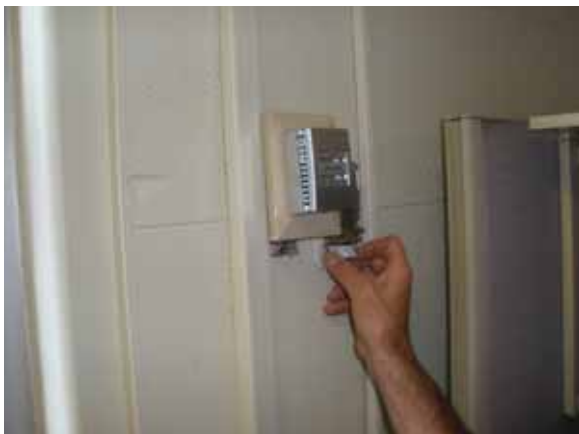
Fig. 2.4.A.12 - Pneumatic Thermostat

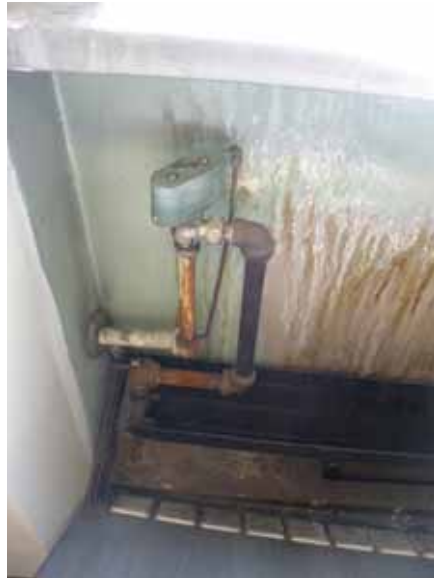
Fig. 2.4.A.13 - Pneumatic Control Valve (Convector)

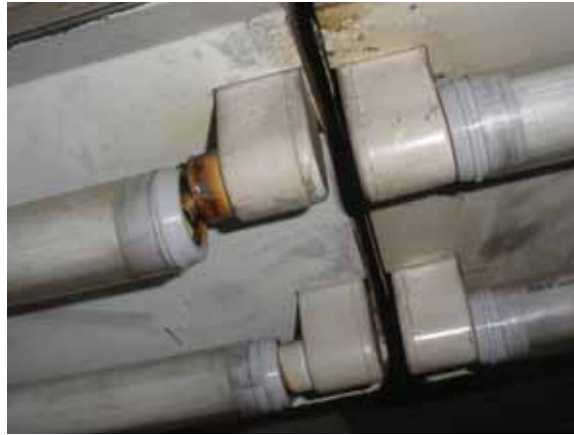
Fig. 2.4.B.1 - Broken bulb hanging

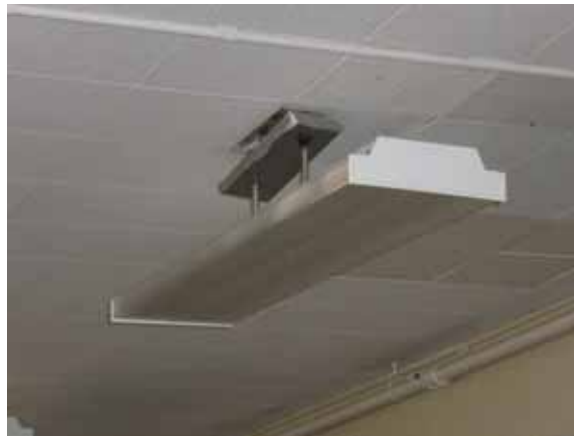
Fig. 2.4.B.2 - Wire cover hanging

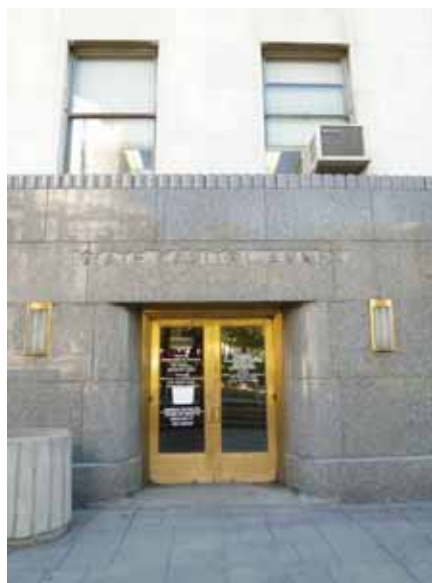
Zone 1 Exterior Facade: North entry with curved reveal at the door

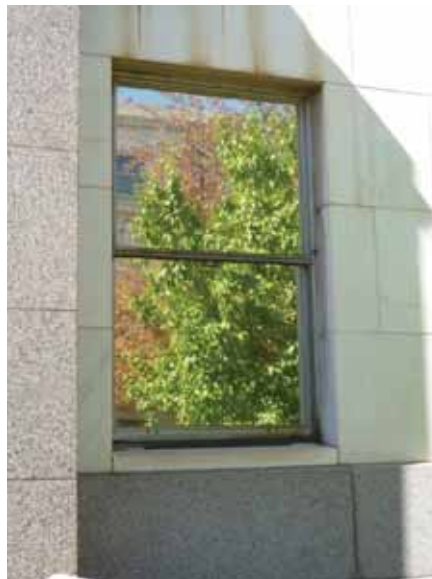
Zone 1 Exterior Facade: Typical window with some rusting and peeling paint

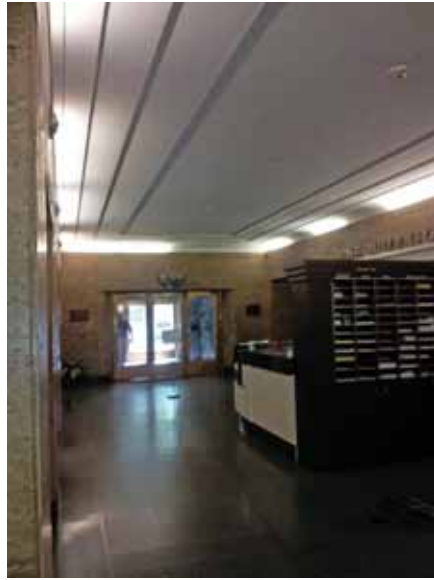
Zone 2 Interior Lobbies and Circulation: First floor central lobby with terrazzo flooring, marble wall panels and a shallow plaster coffer ceiling

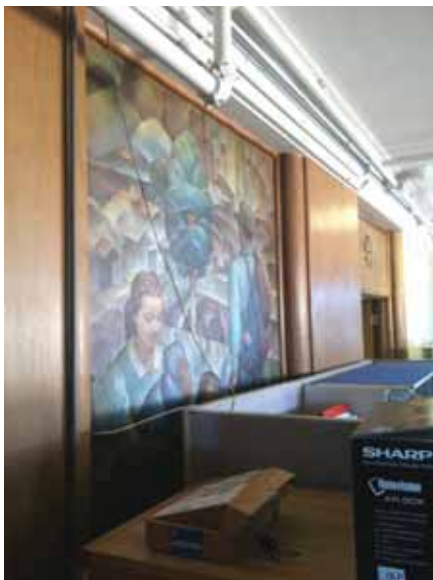
Zone 3 Hearing Room: Original mural painting

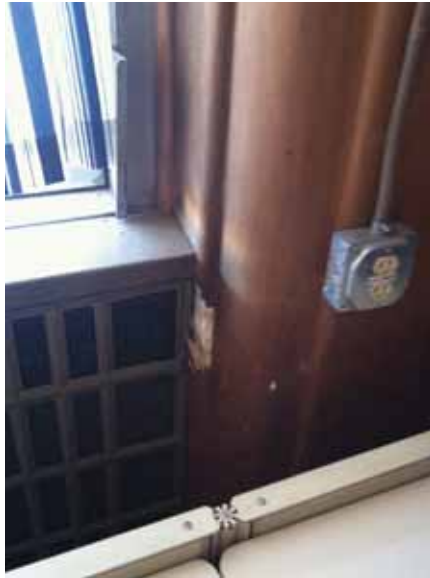
Zone 3 Hearing Room: Wood veneer wraps around the bullnose at the window opening

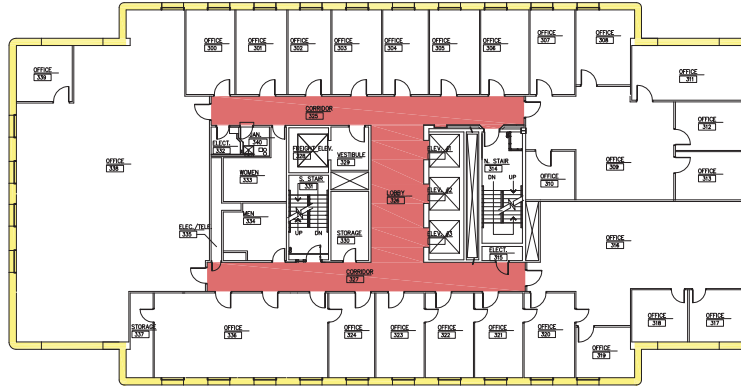
1 3rd FLOOR ZONING PLAN  
1/32" = 1'-0"

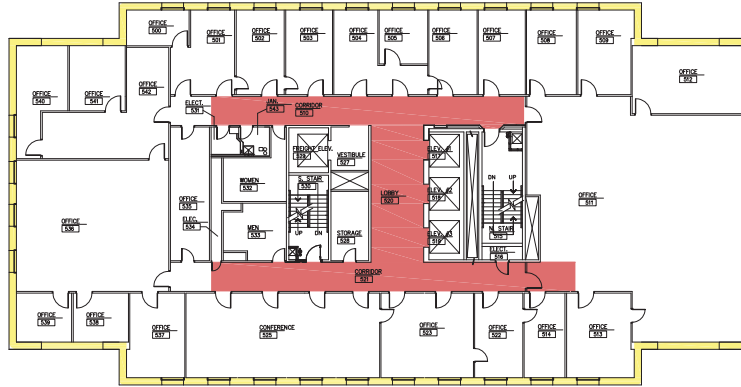
1 5th FLOOR ZONING PLAN  
1/32" = 1'-0"

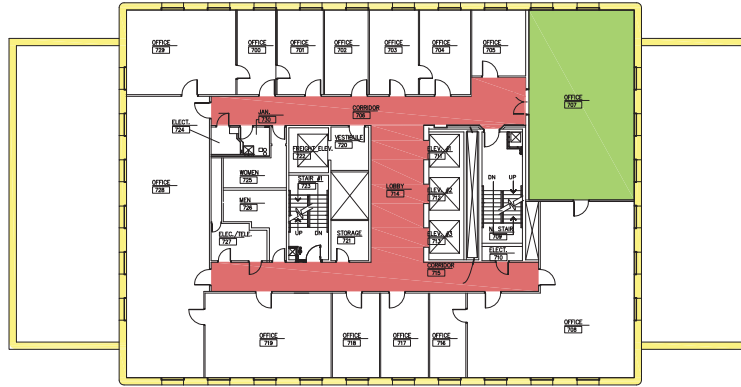
1 7th FLOOR ZONING PLAN  
1/32" = 1'-0"

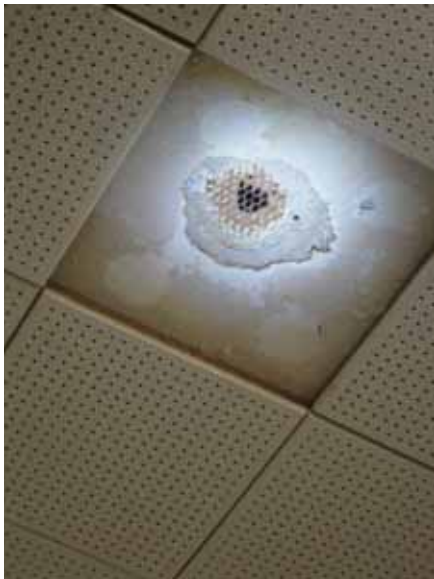
Fig. 3.1.C.1 One-foot square perforated ceiling tiles glued to the plaster ceiling in poor condition.

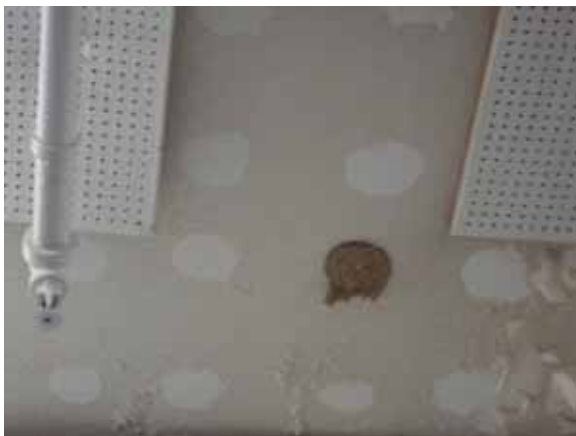
Fig. 3.1.C.2 One-foot square perforated ceiling tiles glued to the plaster ceiling in poor condition.

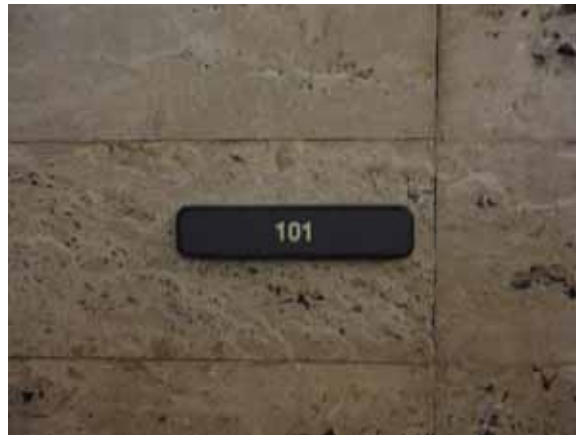
Fig. 3.1.C.3 Grout missing in joints between golden travertine marble panels noted throughout.

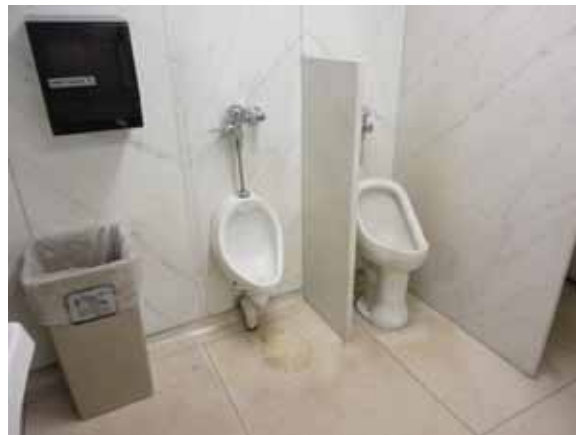
Fig. 3.1.C.4 Typical condition of terrazzo flooring in restrooms noted throughout.

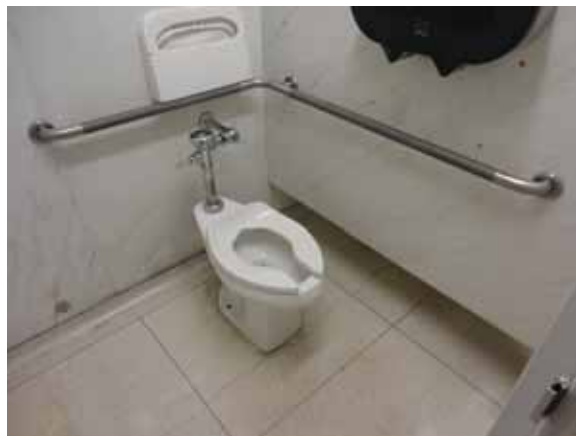
Fig. 3.1.C.5 Typical condition of terrazzo flooring in restrooms noted throughout.

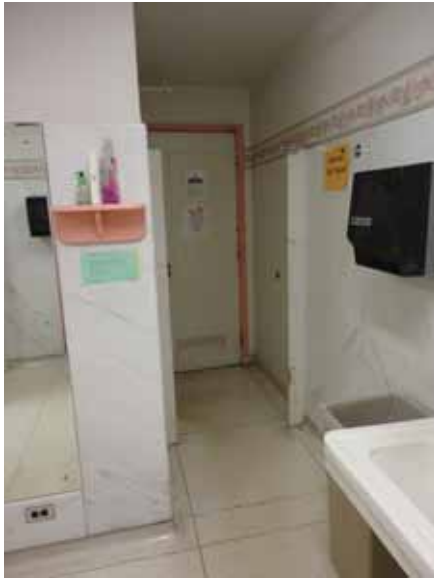
Fig. 3.1.C.6 Typical condition of terrazzo flooring in restrooms noted throughout.

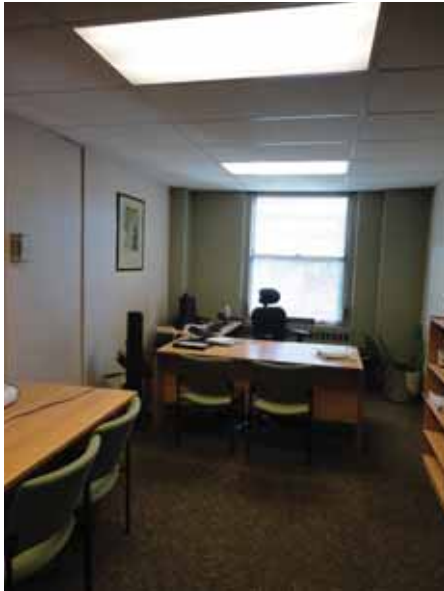
Fig. 3.3.C.1 Minor sagging of 2x4 acoustic ceiling tiles in an office.

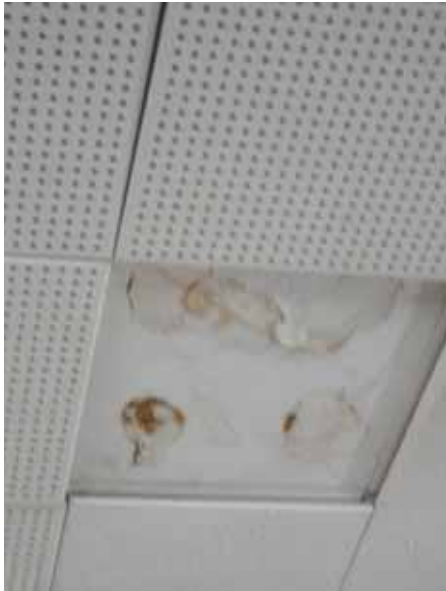
Fig. 3.7.C.1 One-foot square perforated ceiling tiles glued to the plaster ceiling in poor condition.

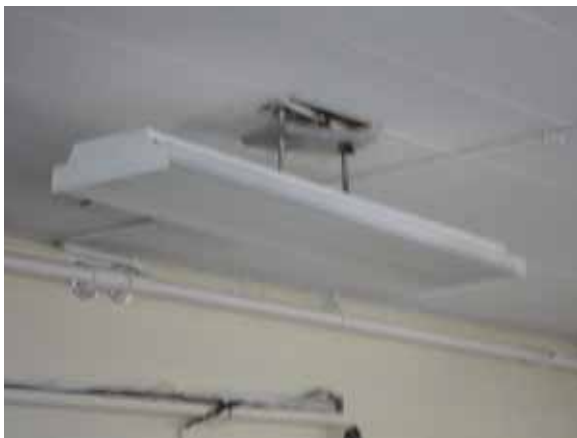
Fig. 3.7.C.2 Light fixture pulling loose from the ceiling.

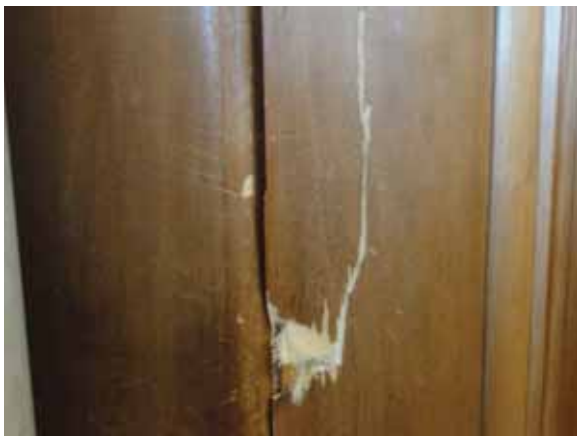
Fig. 3.7.C.3 Damaged wood wall paneling in Office 707 is part of an historic Hearing Room.

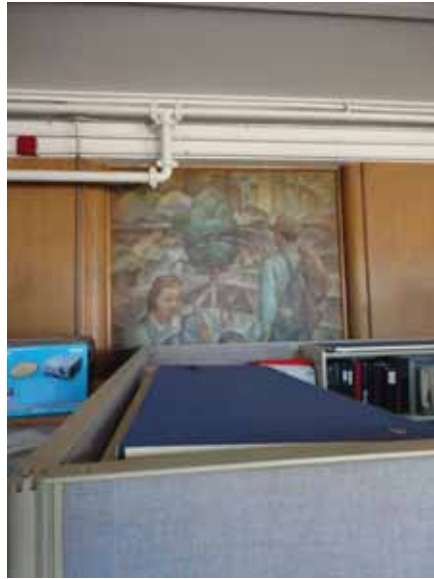
Fig. 3.7.C.4 Wall paneling and artwork in Office 707 to be protected per the historic designation of the building.

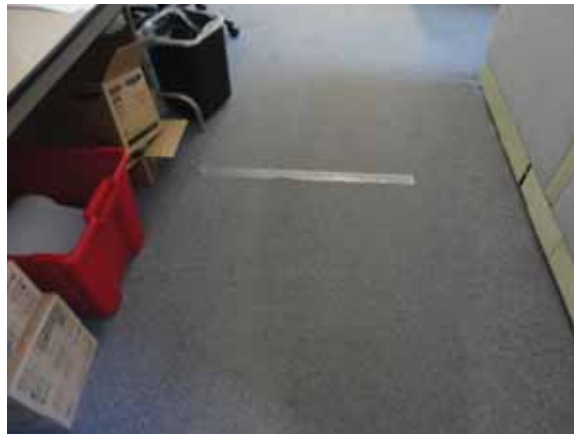
Fig. 3.7.C.5 Taped carpet seam creating a tripping hazard.

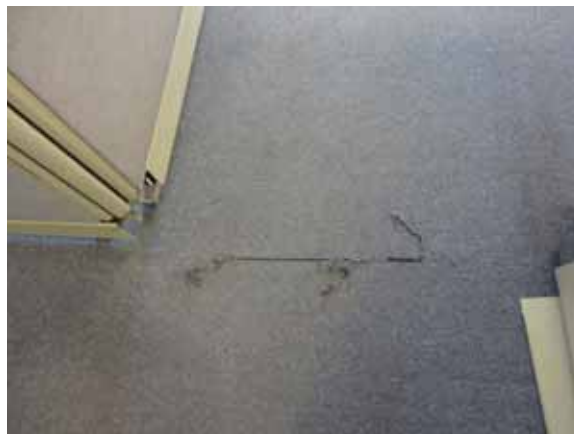
Fig. 3.7.C.6 Carpet seam pulling loose and creating a tripping hazard.

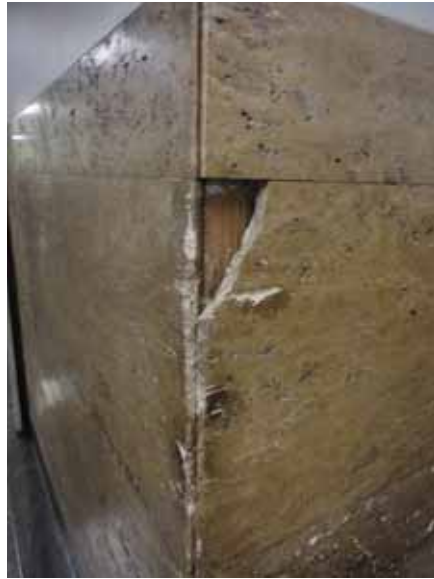
Fig. 3.8.C.1 Damage to golden travertine marble in the Basement elevator lobby.

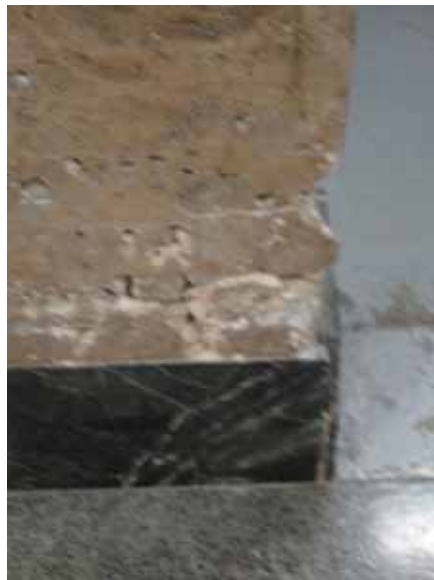
Fig. 3.8.C.2 Damage to golden travertine marble in the Basement elevator lobby.

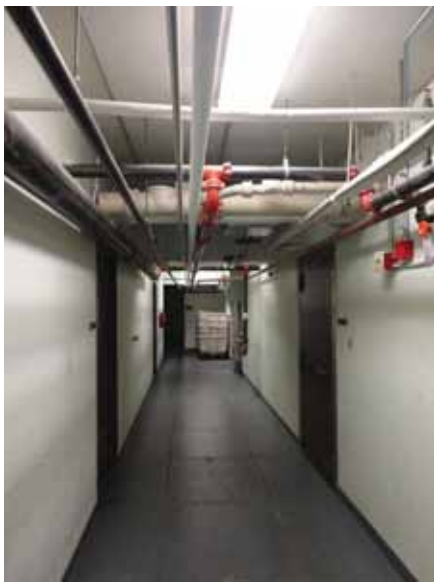
Fig. 3.9.C.1 Minor damage to the main service corridor walls and concrete floors.
