CAPITOL COMPLEX MASTER PLAN
FINDINGS & RECOMMENDATIONS (F & R) NEEDS ASSESSMENT
CENTENNIAL BUILDING, 1313 SHERMAN STREET (DENVER)

NOVEMBER 2014

**FINDINGS & RECOMMENDATIONS (F&R) NEEDS ASSESSMENT
CENTENNIAL BUILDING
1313 SHERMAN STREET (DENVER)**

November 2014

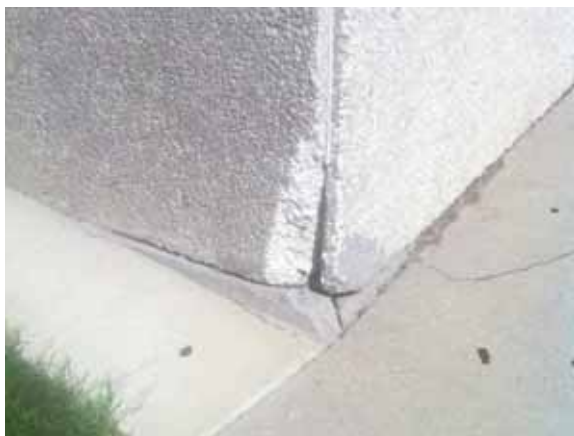
Fig. 2.1.A.1 Spalling at an exterior corner of the building.

- Clean soiled precast aggregate panels.
- Repair or replace damaged precast aggregate panels at the south-east and south-west corners and under the windows of the 1B (Basement) Floor on the north side of the building.
- Remove and replace the damaged precast aggregate panels on the north side of the Penthouse on the Roof.

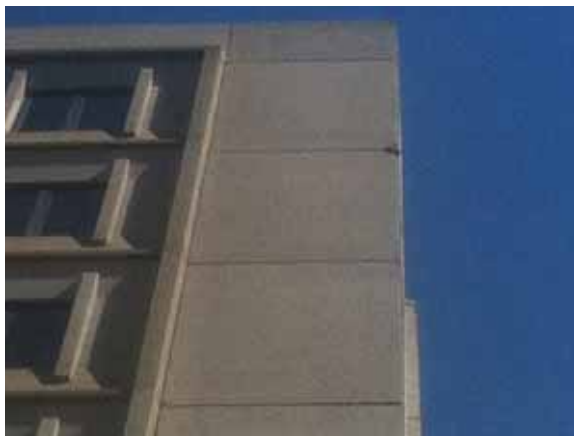
Fig. 2.1.A.2 Spalling at an exterior corner of the building.

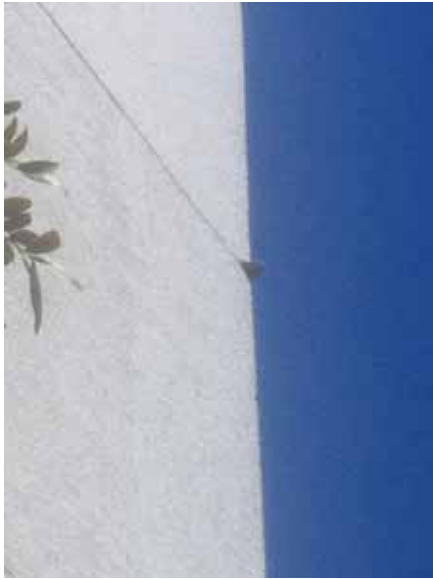
Fig. 2.1.A.3 Piece of aggregate lodged in the side of the building at the south-east corner.

- Remove loose pieces of aggregate from the side of the building.
- Examine all precast aggregate panel support clips for evidence of damage or corrosion and repair or replace.

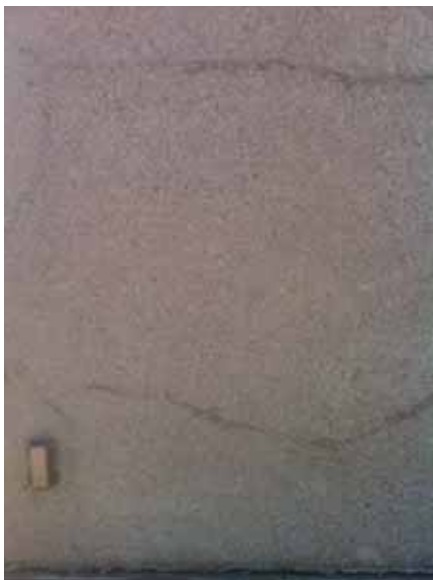
The panels along the north side of the Penthouse at the Roof Level are in poor condition with extensive cracking (see Fig. 2.1.A.4) and shedding of the aggregate (see Fig. 2.1.A.5). The cracks were poorly repaired at some point and the sealant that was used has stained the panels (see Fig. 2.1.A.6). Spalling was observed along the inside face of the parapet at the control joints (see Fig. 2.1.A.7). Sealant failure between the panels and along the control joints is widespread and freeze/thaw damage to the panels and corrosion of the panel attachment clips is likely resulting (see Fig. 2.1.A.8 and Fig. 2.1.A.9).

Fig. 2.1.A.4 Cracked panels, Penthouse Level.

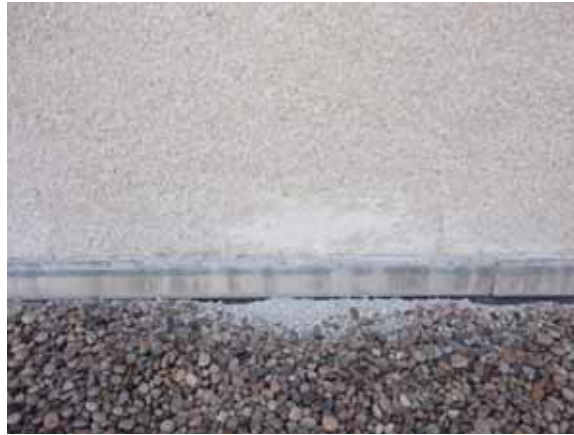
Fig. 2.1.A.5 Aggregate shedding from Penthouse panels.

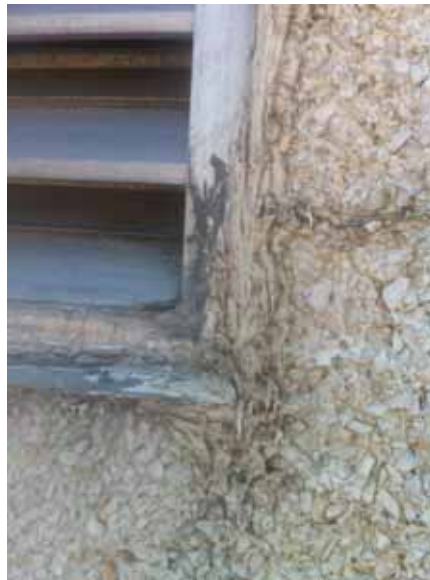
Fig. 2.1.A.6 Poor sealant repair and resulting staining of precast aggregate Penthouse panels.

- Remove existing sealant around panels and in control joints and replace with new sealant. Install backup materials as necessary. Sealant, backup materials, and preformed joint fillers shall be nonstaining. Materials impregnated with oil, bitumen or similar materials should not be used.

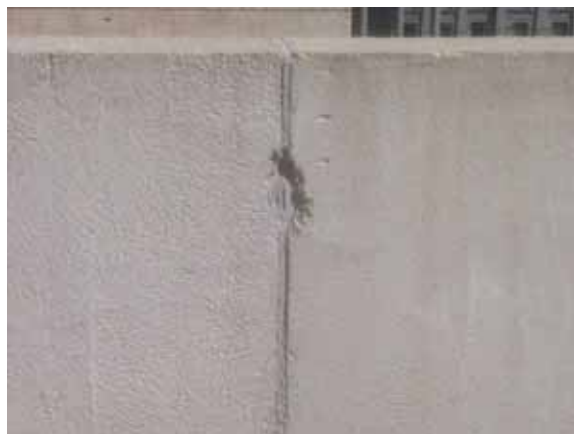
Fig. 2.1.A.7 Spalling at control joint, inside face of roof parapet.

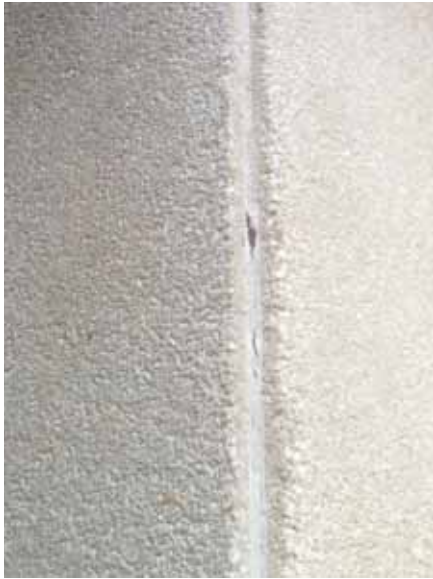
Fig. 2.1.A.8 Sealant failure at control joints.

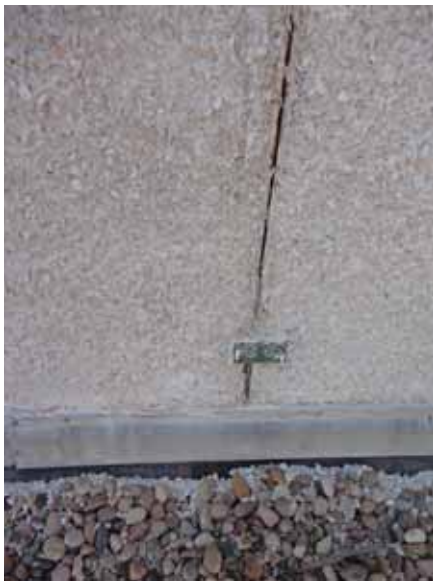
Fig. 2.1.A.9 Sealant failure at joints between precast aggregate panels.

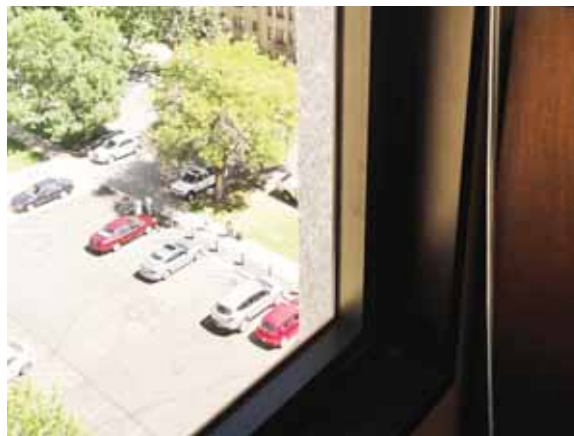
The windows from the First Floor and up are single-pane, operable windows that are original to the building (see Fig. 2.1.A.10). The windows at the 1B (Basement) Floor are the only windows in the building that are double-pane. Sealant failure around the windows is widespread and is likely contributing to the minor corrosion of the window frames (see Fig. 2.1.A.11).

Fig. 2.1.A.10 Single-pane, operable windows.

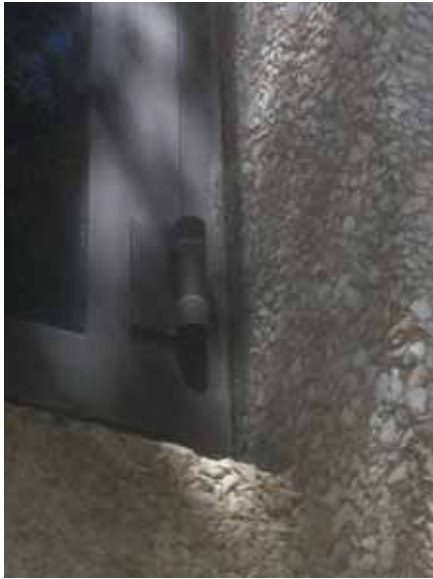
Fig. 2.1.A.11 Sealant failure around windows.

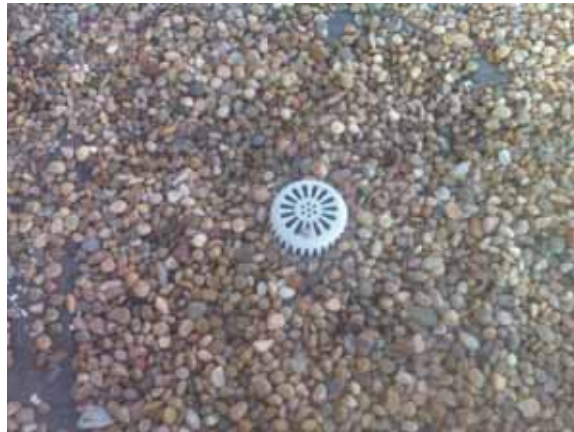
The main roof is ballasted and is thin in spots, exposing the roof membrane (see Fig. 2.1.A.12). With the recent rain, major leaks were reported. The roof

Fig. 2.1.A.12 Area where ballast is thin and roof membrane is exposed.

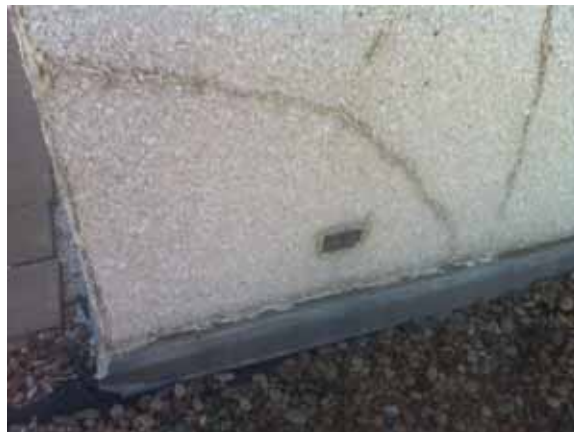
Fig. 2.1.A.13 Corrosion of flashing around the base of the Penthouse.

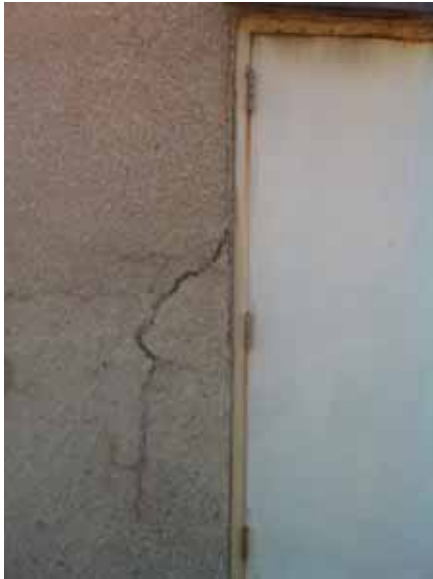
The doors and door frames to the roof are rusting (see Fig. 2.1.A.14 and Fig. 2.1.A.15).

Fig. 2.1.A.14 Rusting door and door frame to the Penthouse and cracked precast panel.

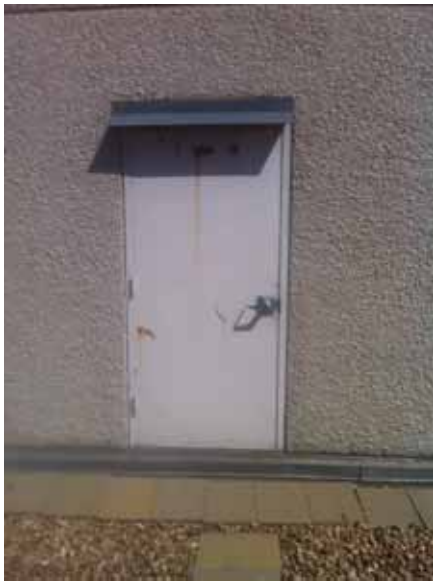
Fig. 2.1.A.15 Rusting door to the Penthouse.

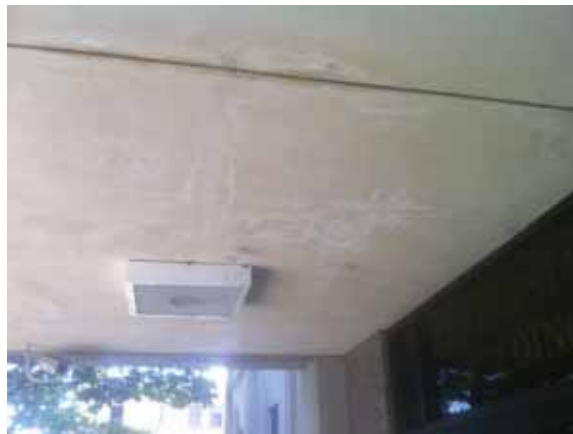
The East, Sherman Street Entrance and the North Entrance canopies both show obvious signs of water damage from below (see Fig. 2.1.A.16).

Fig. 2.1.A.16 Water damage observed under the east Sherman Street Entrance canopy.

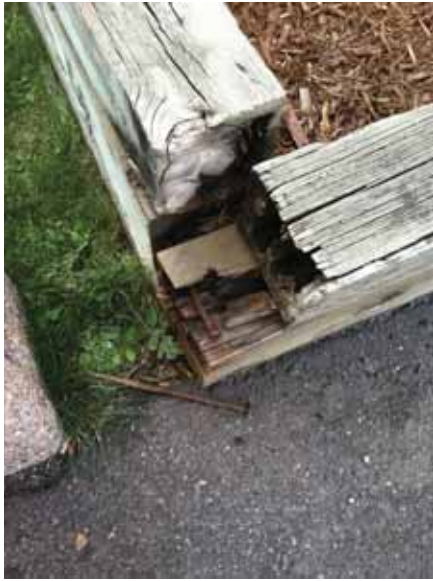
Fig. 2.1.A.17 Damaged railroad ties with exposed nails at raised landscaping bed along the east Sherman Street facade.

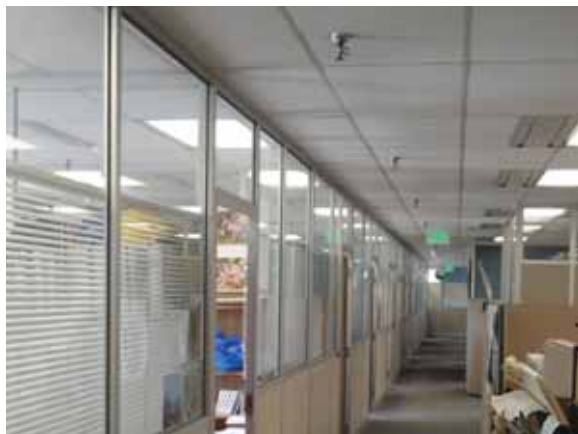
There is a fully automatic sprinkler system throughout the building (see Fig. 2.1.B.1). It was reported that there have been several known failures with the sprinkler heads.

Fig. 2.1.B.1 Typical automatic sprinkler system configuration found throughout the building.

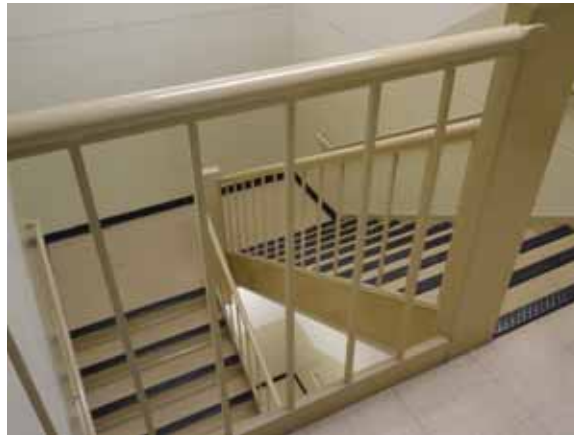
In general, the exit stairs comply with the code requirements for stairs, with the exception of the handrails. The spacing between the handrail posts exceeds the code-maximum of four inches (Fig.2.1.B.2).

Fig. 2.1.B.2 Exit stair railings.

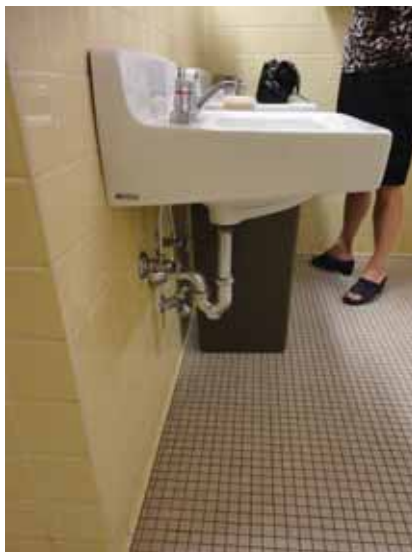
Fig. 2.1.C.1 Accessible lavatory without insulation wrapped around the pipes.

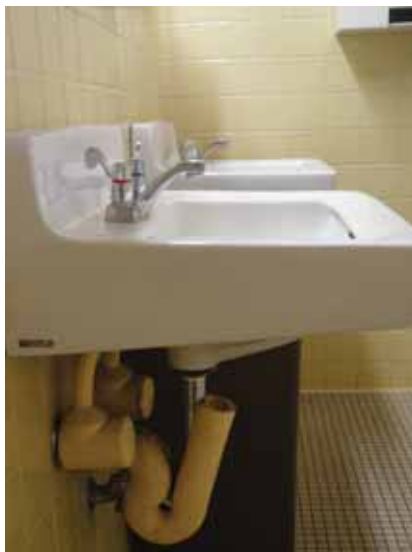
Fig. 2.1.C.2 Insulation coming loose around an accessible lavatory pipe.

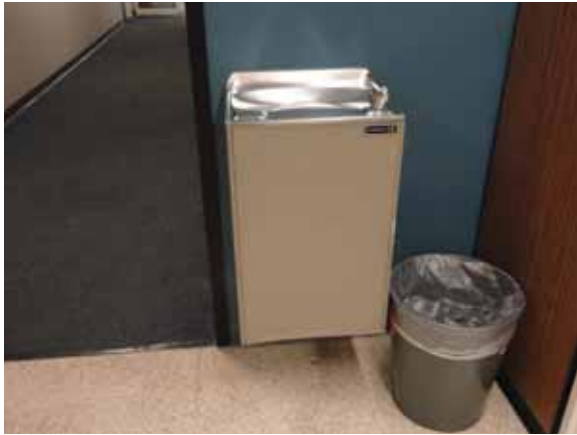
The drinking fountains throughout the building are non-accessible (see Fig.2.1.C.3) with the exception of one accessible fountain that exists on the east side of the Third Floor.

Fig. 2.1.C.3 Typical non-accessible drinking fountain found throughout the building.

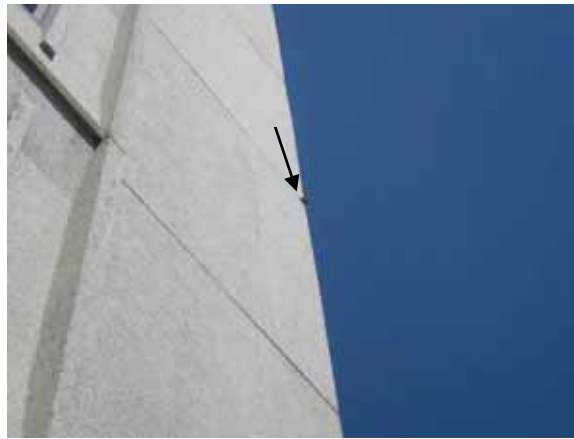
Fig. 2.2.A.1

The building's exterior appears to be in fair condition with the exception of a few areas. Small spalls were observed along the exterior of the building (Fig. 2.2.A.1).

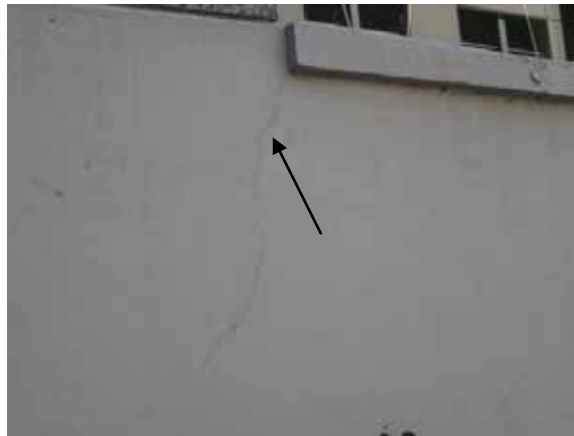
Fig. 2.2.A.2

Minor cracking was observed around the windows along the northwest wall at Level 1B (Fig. 2.2.A.2). The cracks are not a structural concern at this time and should be monitored for additional movement.

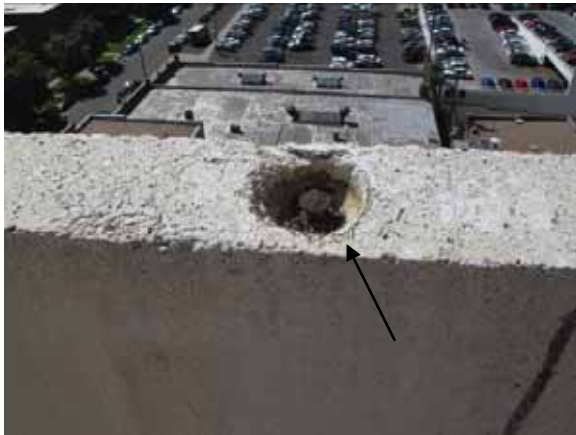
Fig. 2.2.A.3

The precast panel lifting points are corroding and have spalled the grout from the pockets (Fig. 2.2.A.3). The spalled grout allows water to collect in the pockets and cause additional corrosion and spalling.

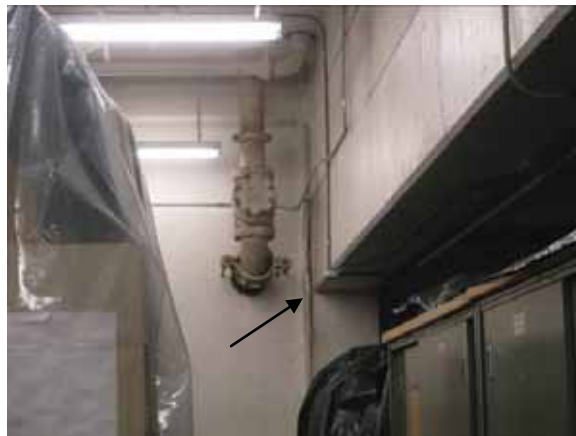
Fig. 2.2.B.1

Leaks were reported on Level 3B beneath the loading dock (Fig. 2.2.B.1). The area appeared to be dry at the time of our site visit and access into the locked area was not provided. The source of the leaks should be investigated further so that the proper repair recommendations can be made. A previous leak on the east side of Level 3B was reported. At this location, it was reported to have been repaired with application of a waterproofing membrane on the exterior of the building.

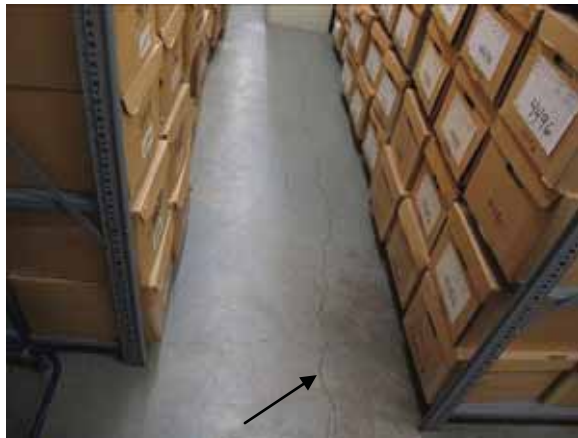
Fig. 2.2.B.3

Cracks were observed on the concrete floor throughout Level 2B (Fig. 2.2.B.3). The cracks are minor to moderate in size.

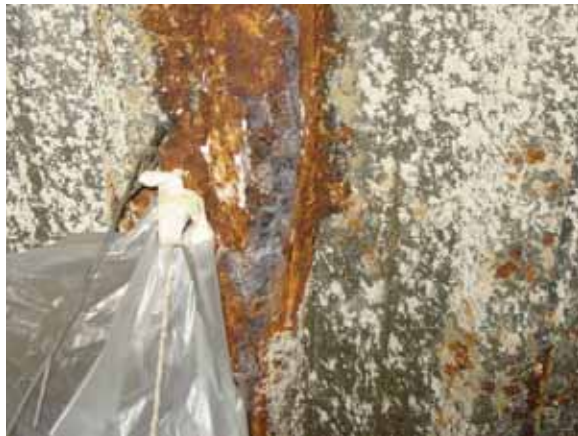
Fig. 2.2.B.4

Corroded steel decking was observed at the roof level on the north side of the elevator lobby (Fig. 2.2.B.4). The steel deck acts as the formwork for the concrete slab and is not a structural concern. The water leak should be repaired to prevent additional deterioration.

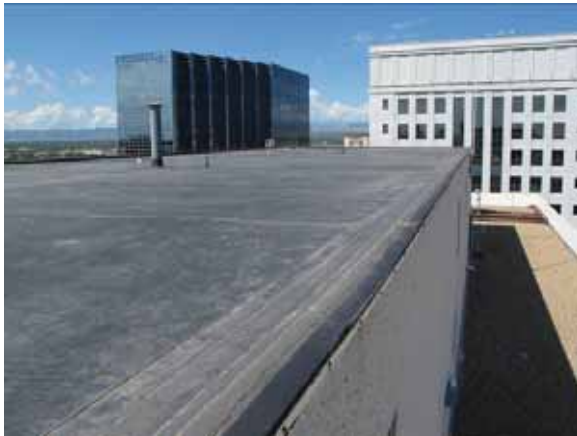
Fig. 2.2.C.1

No parapets were provided along the penthouse roof (Fig. 2.2.C.1). The fall in this area is approximately 15 to 20 feet to the roof below. A fall protection system should be provided for access near the exposed edges to meet current safety codes.

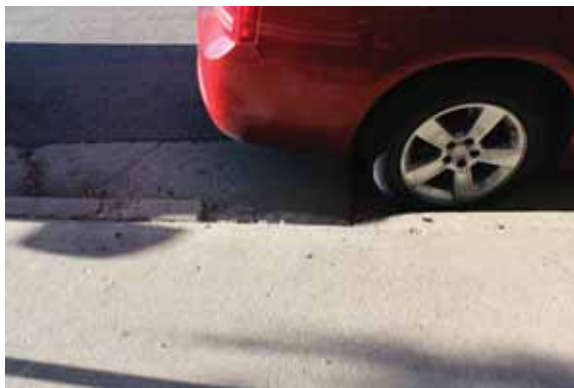
Numerous locations of broken concrete and concrete cracking was observed. Repair or replace broken or cracked concrete.

Figure 2.3.A.8 Site Broken Concrete Curb, Recommended for Replacement

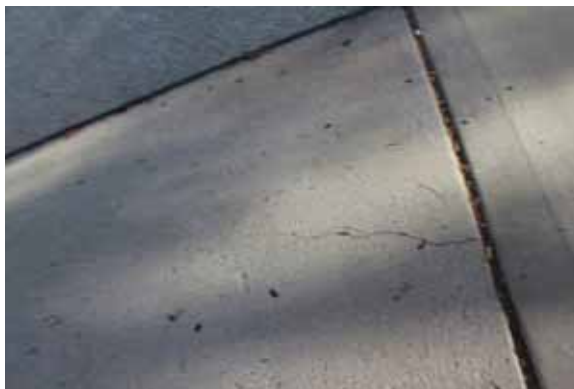
Figure 2.3.A.9 Site Concrete Crack

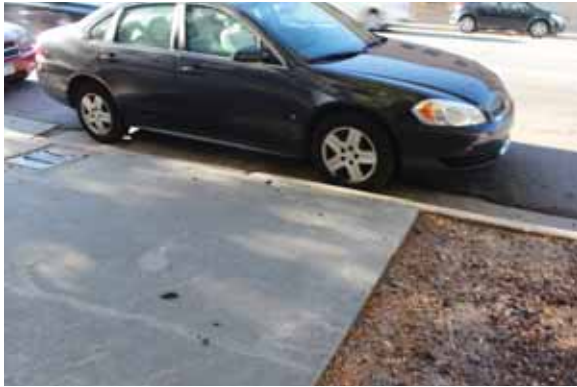
Figure 2.3.A.10 Site
Concrete Crack,
Recommended for
Replacement

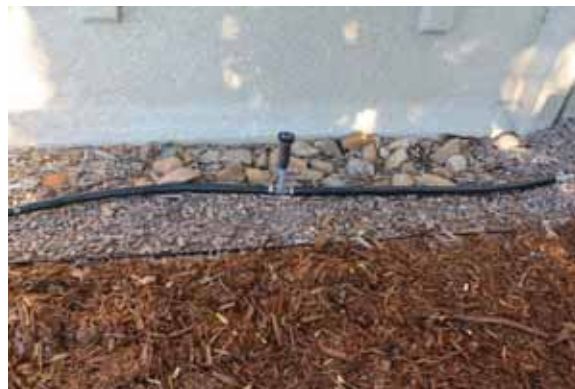
An irrigation line was observed close to the foundation of the building (Fig. 2.3.B.1). Typical geotechnical recommendations do not allow irrigation within 10' of a building perimeter. Irrigation this close may cause wetting of the building foundation, which could lead to numerous problems including settlement. Although it appears that this irrigation may not be used regularly since the surrounding surface is mostly rock and mulch, this irrigation line should be relocated and watering methods re-evaluated.

Figure 2.3.B.1 Irrigation along the Building Perimeter

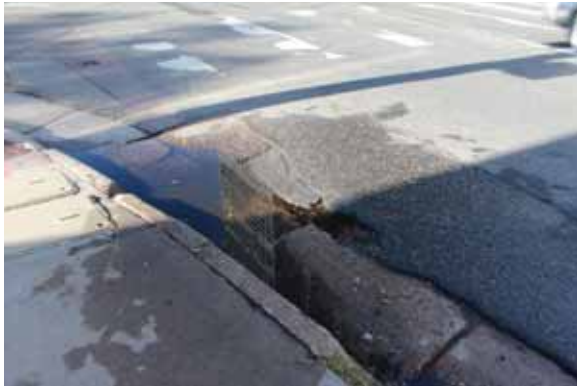
Figure 2.3.B.2 Localized Ponding

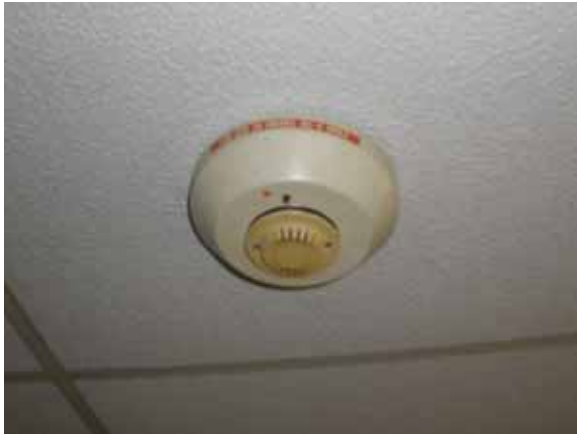
Fig. 2.4.A.5 - Old smoke detector

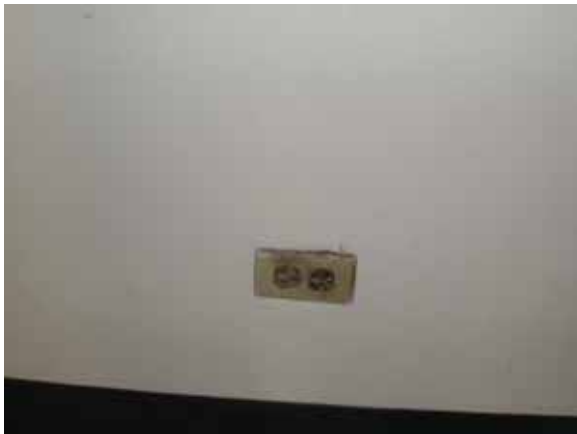
The receptacles are in bad condition and past their useful life (see Fig. 2.4.A.6, Fig. 2.4.A.7). The distribution system for the power in the office spaces is a Walkerduct Electrified Floor System (tombstone floor boxes) which is out of date and a tripping hazard and needs to be replaced.

Fig. 2.4.A.6 - Burnt out receptacle

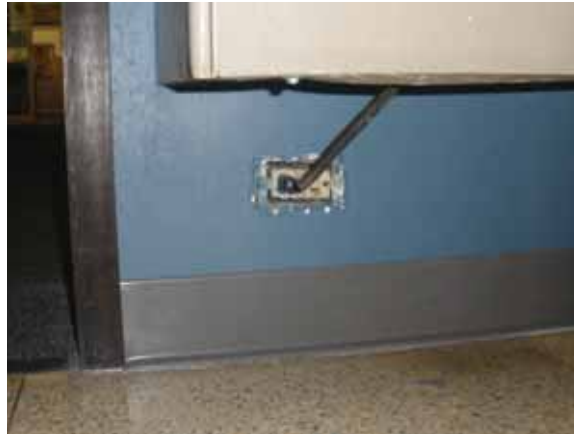
Fig. 2.4.A.7 - No cover on receptacle

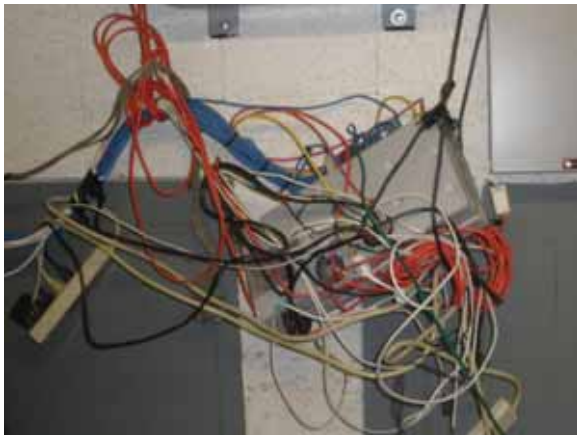
Fig. 2.4.B.1 - Data hanging in front of electrical panel

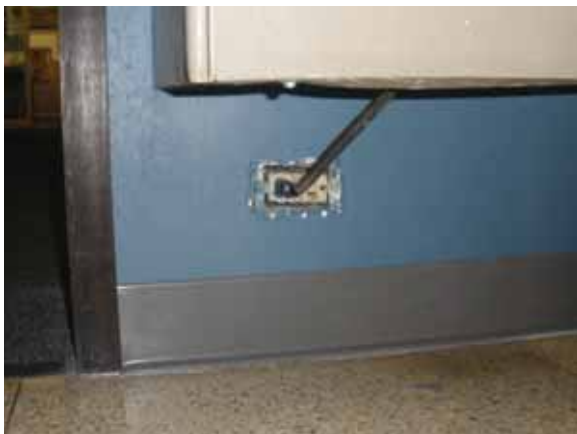
Fig. 2.4.B.2 - Receptacle missing cover

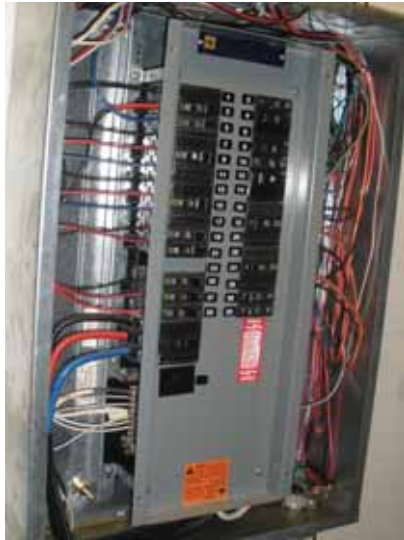
Fig. 2.4.B.3 - Missing panel cover

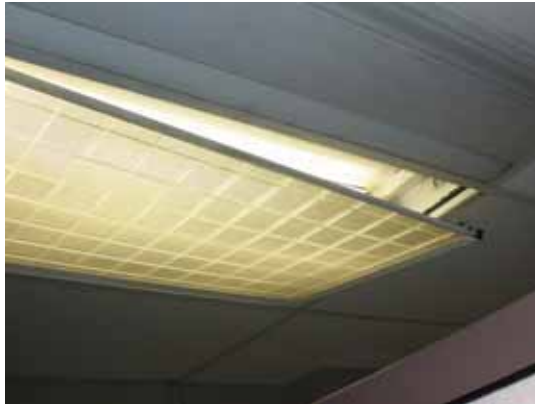
Some light fixture covers in office spaces are not supported properly (see Fig. 2.4.B.4).

Fig. 2.4.B.4 - Fixture not fully supported

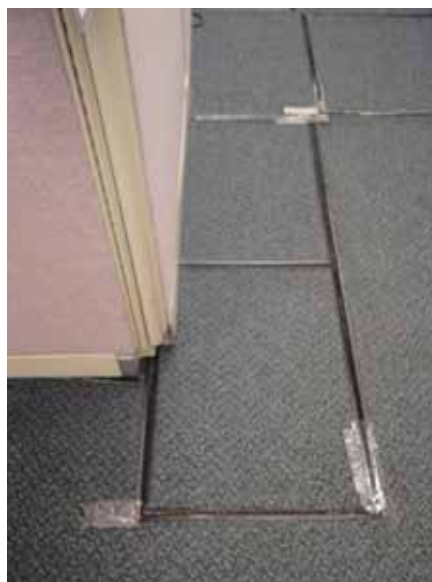
The elevator lobbies from the First Floor to the Eighth Floor, located in the middle of the core circulation corridor, have terrazzo flooring, wood laminate panels cladding the walls, and a dropped 2x4 acoustic ceiling. The east and west ends of the central circulation corridors, with the stairwells, restrooms, and service closets, have carpet flooring, gypsum board walls, and a slightly lower dropped 2x4 acoustic ceiling. The flooring in the restrooms is one-inch square tile and the walls are clad in three-inch square tile. The office spaces which were included in the site survey generally had carpet flooring, gypsum board and movable walls, and 2x4 acoustic ceiling tile. There is a Walkerduct electrified floor system throughout the building office spaces with tombstone floor boxes. The seams between the floor box trenches and the carpet has been taped in some locations (see Fig.3.0.1). This system is out of date and creates a tripping hazard.

Fig. 3.0.1 Walkerduct Electrified Floor System: typical tombstone floor box covers found throughout the building.

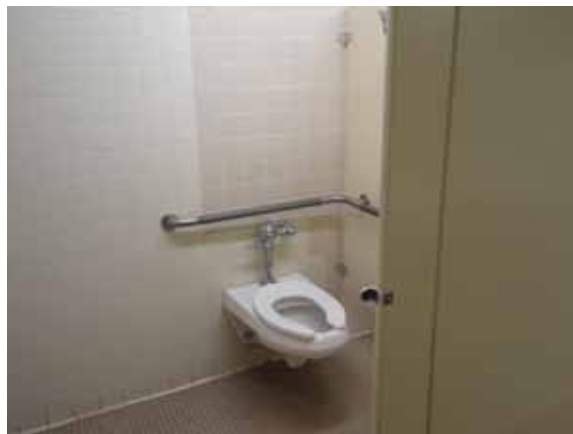
Fig. 3.1.C.1 Tile flooring in restrooms found to be dirty in some locations throughout the building.

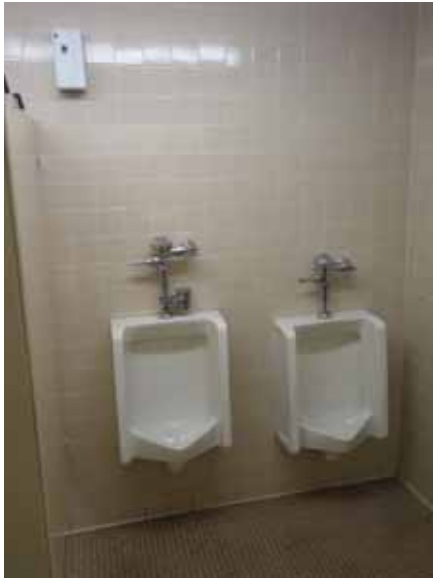
Fig. 3.1.C.2 Tile flooring in restrooms found to be dirty in some locations throughout the building.

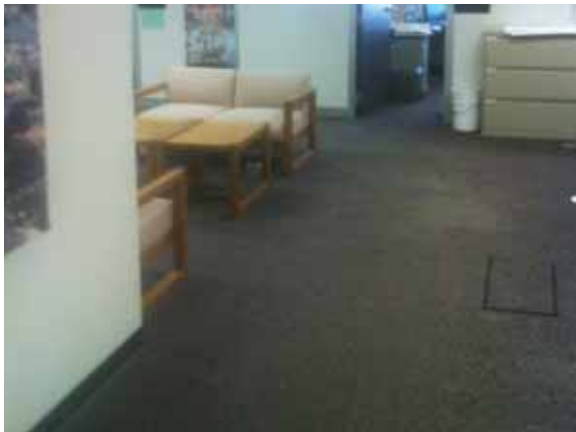
The terrazzo flooring in the elevator lobby of the core circulation corridor is in generally fair condition. The one-inch square floor tile in the restrooms is dirty in some locations but is otherwise in generally fair condition throughout the building. The office spaces that were included in the site survey visit were found to have areas of carpet in generally fair condition as well as large areas of carpet in generally poor condition with signs of deterioration due to aging and numerous stained and dirty areas (see Fig. 3.2.C.1).

Fig. 3.2.C.1 Typical stained, dirty, and generally deteriorated carpet.

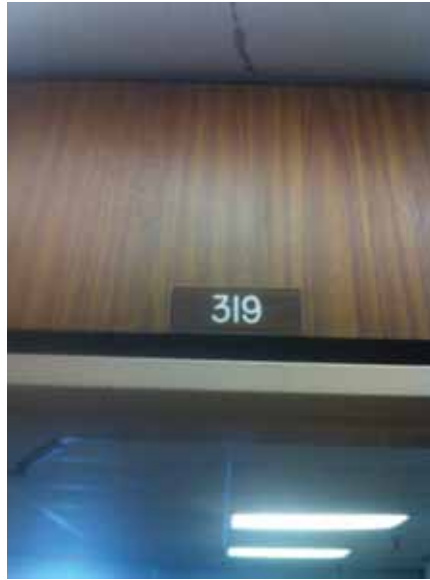
Fig. 3.3.C.1 Damaged 2x4 acoustic ceiling tile at Office 319.

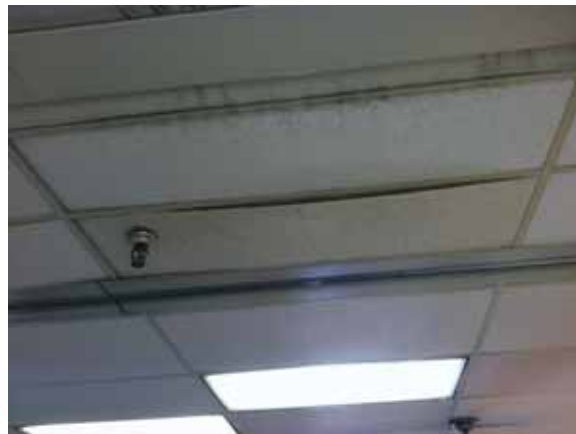
Fig. 3.4.C.1 2x4 acoustic ceiling tiles in generally poor condition.

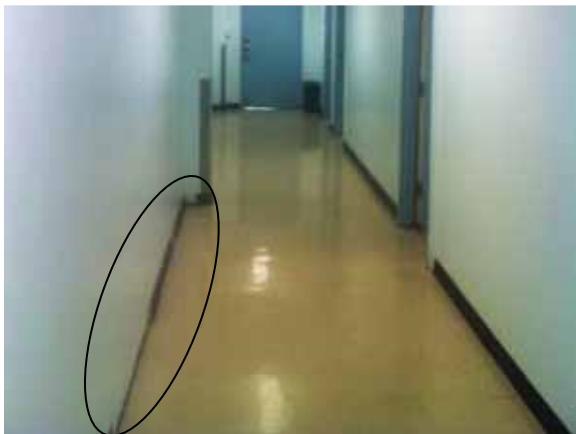
Fig. 3.9.C.1 Vinyl base molding cracking and peeling away from the wall.

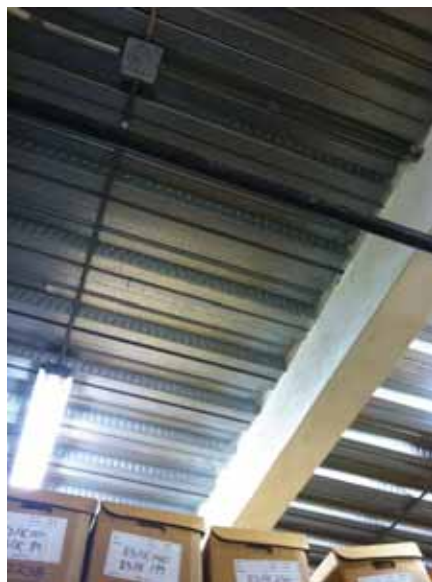
Fig. 3.10.C.1 The Division of State Archives and Public Records storage areas. Exposed metal decking at the ceiling with no fireproofing.
