CAPITOL COMPLEX MASTER PLAN
FINDINGS & RECOMMENDATIONS (F & R) NEEDS ASSESSMENT
CENTENNIAL BUILDING, 1313 SHERMAN STREET (DENVER)

NOVEMBER 2014

**FINDINGS & RECOMMENDATIONS (F&R) NEEDS ASSESSMENT
CENTENNIAL BUILDING
1313 SHERMAN STREET (DENVER)**

November 2014

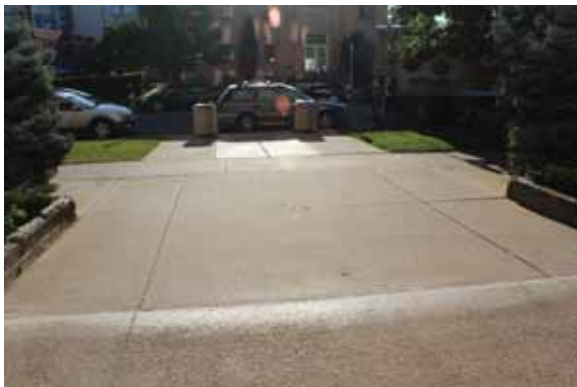
Figure 2.3.A.3 – Main Entrance Apron

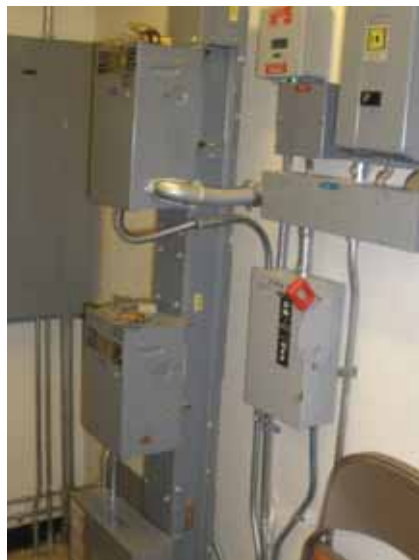
Most of the Centennial building's electrical gear appears to be original. There are 13.2kV feeders that come into the basement that feed the building's 1500kVA transformer. The building transformer feeds a 480V, 2500amp switchgear in the basement which provides power to the rest of the building. The bus duct that feeds each floor in both electrical rooms is rated for 600amps. Both electrical rooms on each floor have 480/277V lighting panels that feed from the bus duct and 208/120V panels that feed through a transformer (see Fig. 2.4.A.1).

Fig. 2.4.A.1 - Bus duct in electrical rooms on each floor

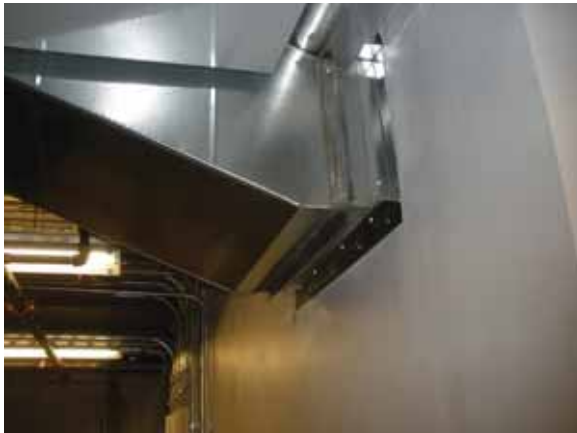
The elevator machine rooms are served by cooling units located in the machine room. The air distribution within the room is via supply air duct work. One unit also serves the electrical room located outside the elevator machine room (see Fig. 2.4.A.12).

Fig. 2.4.A.12 - Elevator
AC Unit Serving Electrical
Room

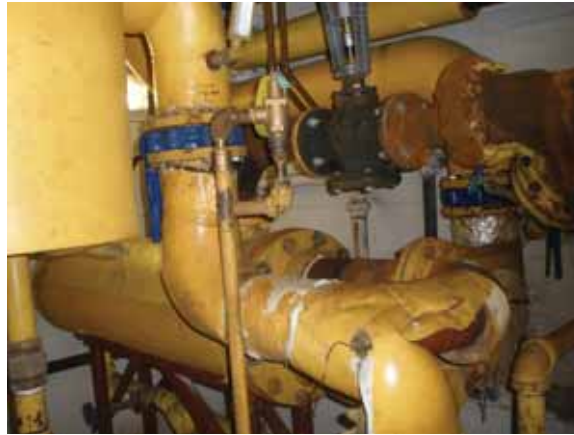
Fig. 2.4.A.14 - Steam / HW Heat Exchanger
