CAPITOL COMPLEX MASTER PLAN
FINDINGS & RECOMMENDATIONS (F & R) NEEDS ASSESSMENT
CENTENNIAL BUILDING, 1313 SHERMAN STREET (DENVER)

NOVEMBER 2014

**FINDINGS & RECOMMENDATIONS (F&R) NEEDS ASSESSMENT
CENTENNIAL BUILDING
1313 SHERMAN STREET (DENVER)**

November 2014

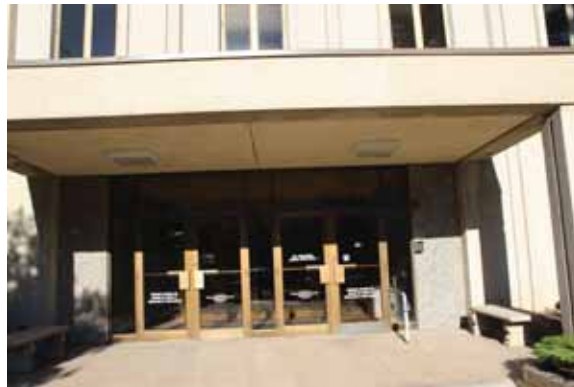
Figure 2.3.A.1 – Centennial Building Sherman Street Entrance

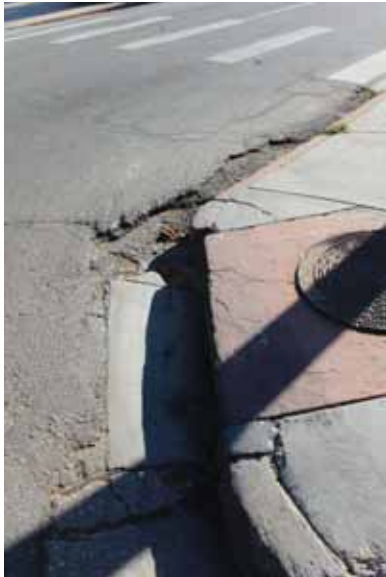
the streets. Runoff is collected by street inlets (Fig. 2.3.A.2) and conveyed by storm sewer west within E. 13th Avenue.

Figure 2.3.A.2 – Street Inlet

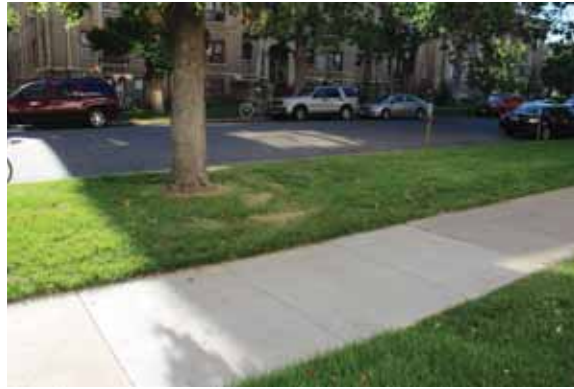
Figure 2.3.A.4 – Public Sidewalk and Treelawn

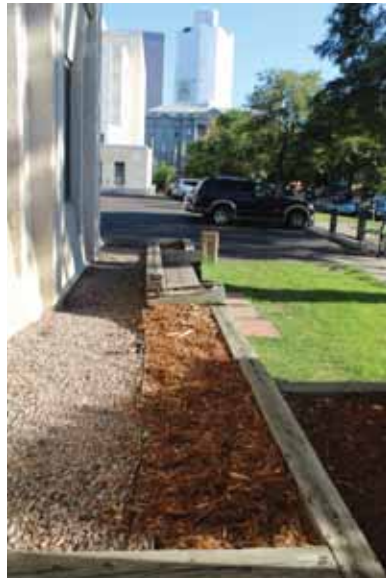
Figure 2.3.A.5 – Landscape Beds

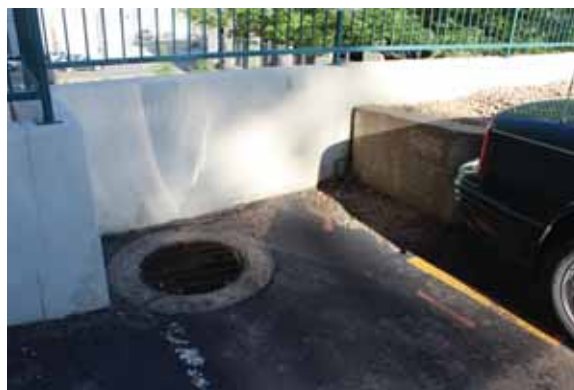
Figure 2.3.A.6 – Parking Garage Area Drain

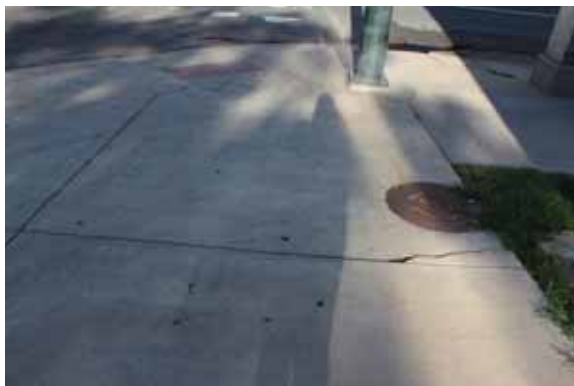
Figure 2.3.A.7 – Street Utilities

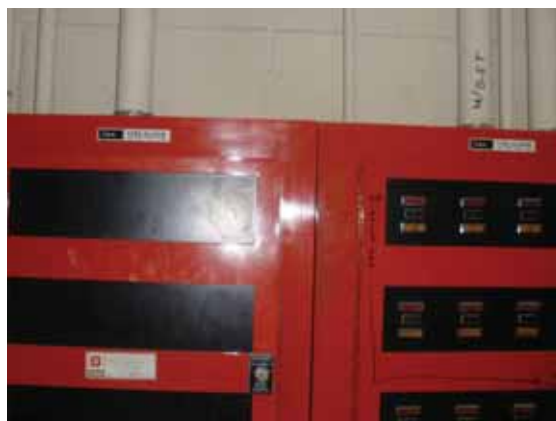
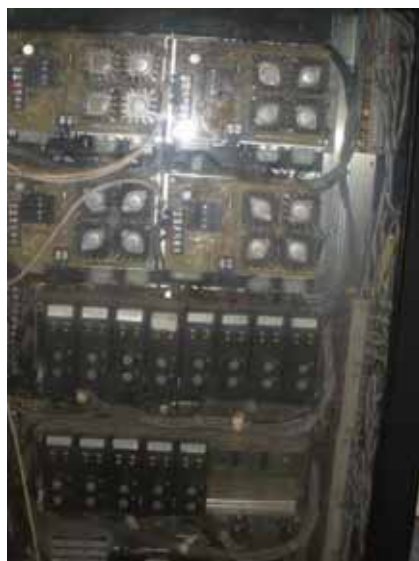
The fire alarm system appears to be original (see Fig. 2.4.A.3, Fig. 2.4.A.4, Fig. 2.4.A.5). The building appears to have full detection and notification. The system is at its limits of capacity; when the fire pump was added a new panel was installed to serve it. There is a mass notification system on all floors and all panels are located in the fire command center. The server room has its own fire alarm system that appears to be less than five years old and appears to be up to code.

Fig. 2.4.A.3 - Old fire alarm system

Fig. 2.4.A.4 - Old fire alarm system

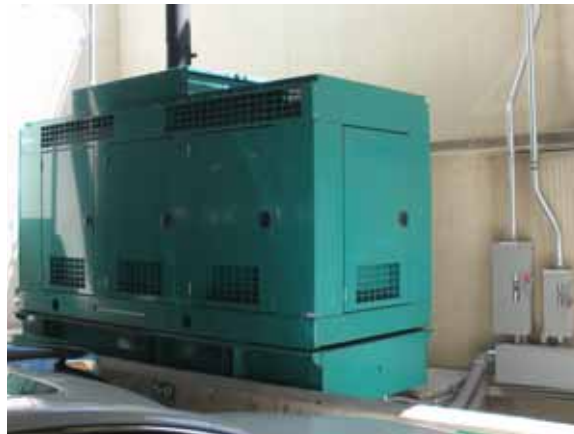
This building has a new emergency generator located in the new garage (see Fig. 2.4.A.8). It feeds the life safety equipment in the building.

Fig. 2.4.A.8 - New emergency generator

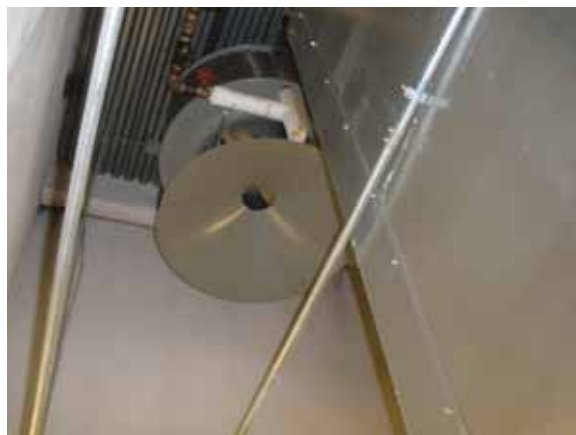
Fig. 2.4.A.9 - Room Unit Heater

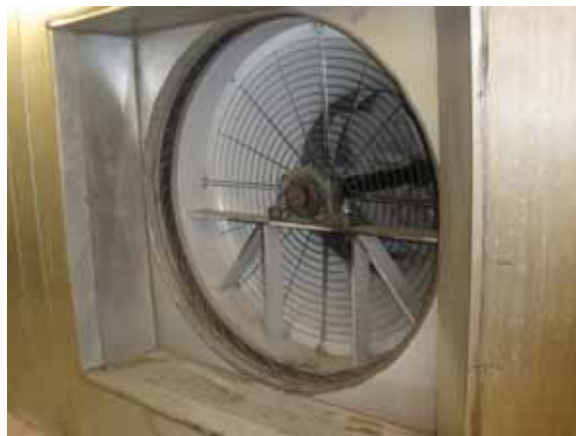
Fig. 2.4.A.10 - AHU Intake within built-up AHU

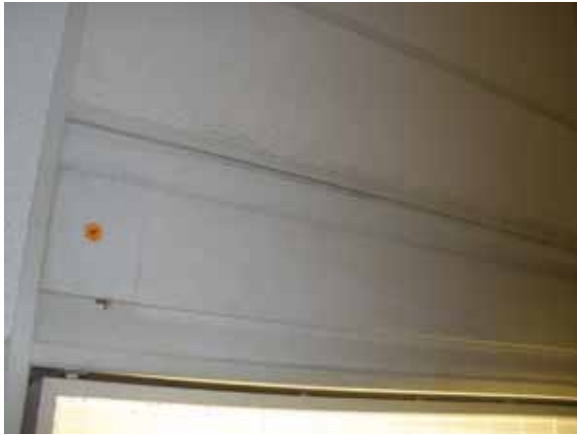
Fig. 2.4.A.11 - VAV Diffuser

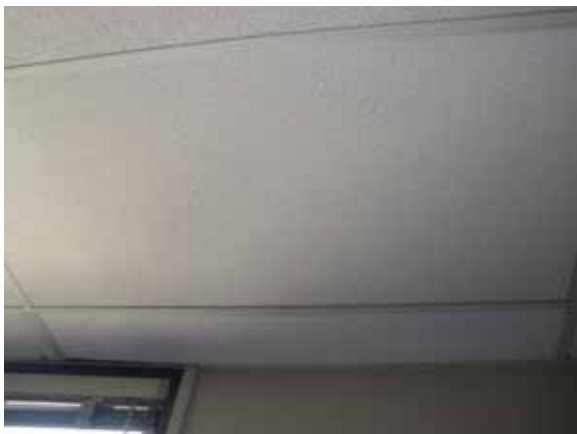
Fig. 2.4.A.13 - Heating
Panel
